DEPARTMENT OF PUBLIC WORKS
BUREAU OF STREET SERVICES
REPORT NO.1

18700 BLOCK WEST MAYALL AVENUE AND ADJACENT STREETS (BOE – 68) – CITYWIDE SIDEWALK REPAIR PROGRAM IN COUNCIL DISTRICT TWELVE REQUEST BOARD OF PUBLIC WORKS TO CONCUR WITH A SIDEWALK REPAIR PROJECT AND APPROVE THE REMOVAL OF SEVEN CANARY ISLAND PINE (PINUS CANARIENSIS) TREES FOR THE RECONSTRUCTION OF THE NON-ADA COMPLIANT PUBLIC SIDEWALK. TREE REPLACEMENTS ARE REQUIRED.

TRANSMITTAL NO. 5

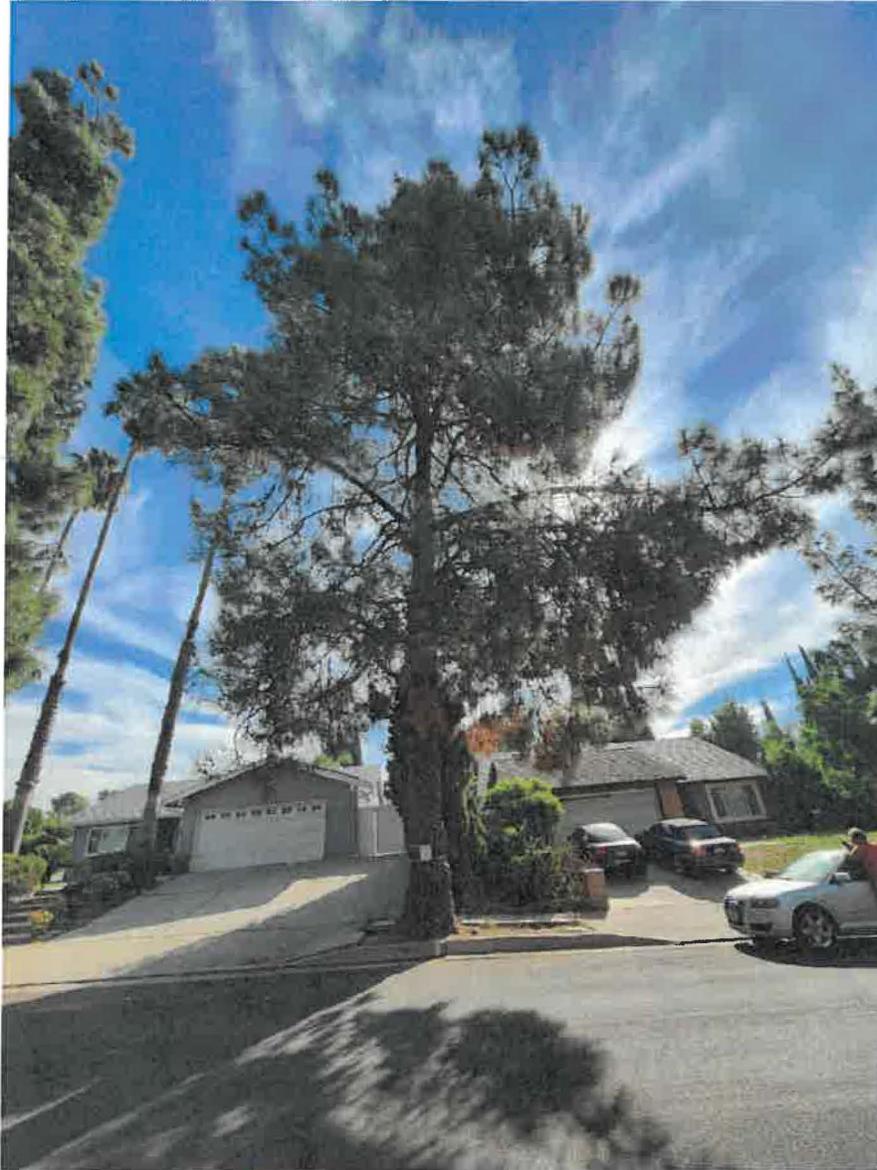
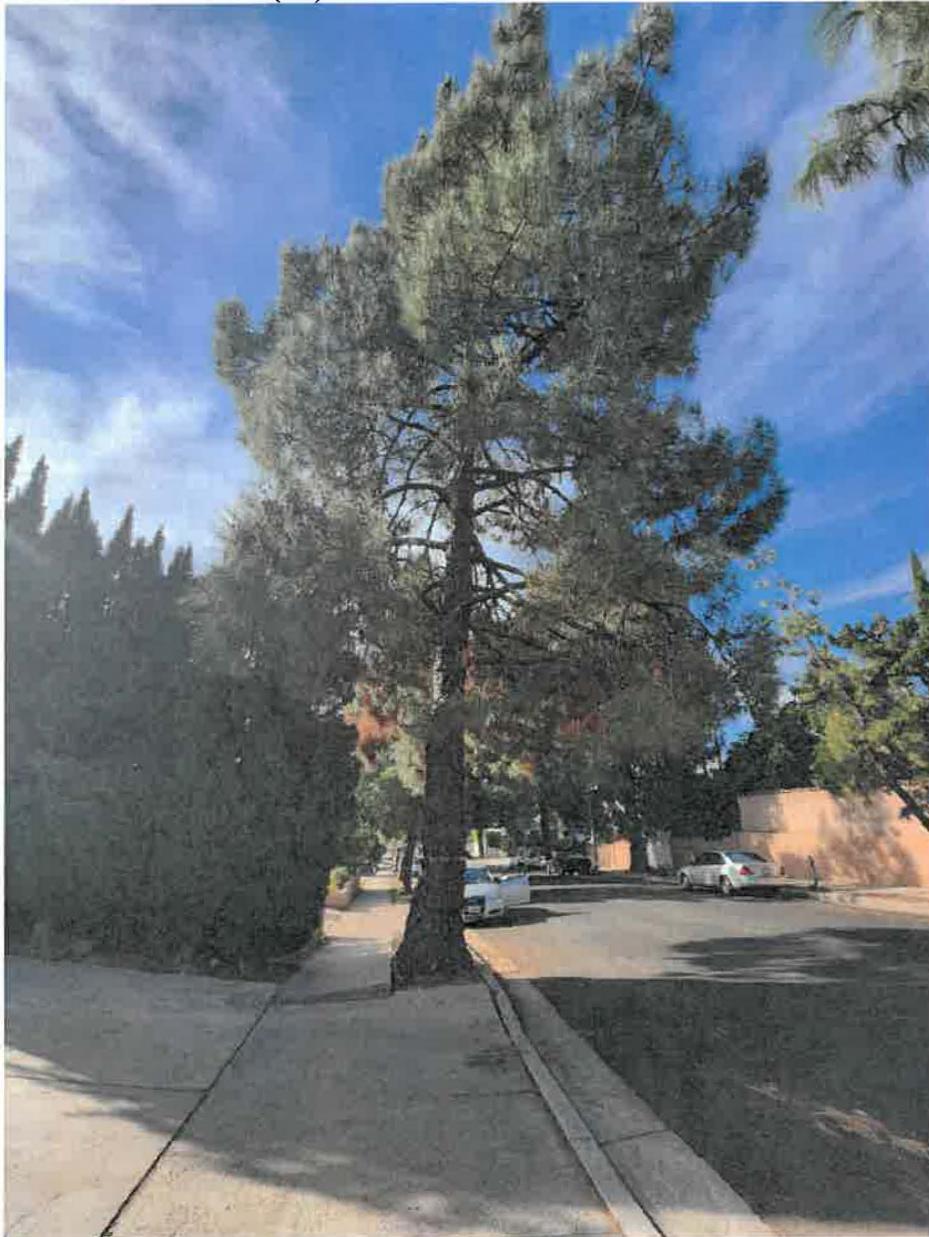
10146 Yolanda Ave (F1)

Proposed to be Removed - UFD cannot ramp over the pine tree roots since the prevailing grade of the street exceeds 5%. The Canary Island pine has an elevated root flare creating severe off grade sidewalk conditions. Large diameter roots are extending under the existing sidewalk. Excessive/ imprudent amount of roots would require pruning to achieve ADA grade requirements & Certificate Of Compliance. Ramping over roots and sidewalk width reduction have been considered as an effort toward tree-preservation yet would not be sufficient due to the extent of repairs surrounding this parkway tree. Root pruning of critical roots will render the trees unstable. Removal is recommended as the best course of action. This genus of trees and its inherent intolerance to root-pruning is the primary factor in UFDs recommendation that no anchoring roots shall be severed at time of Demolition/construction.

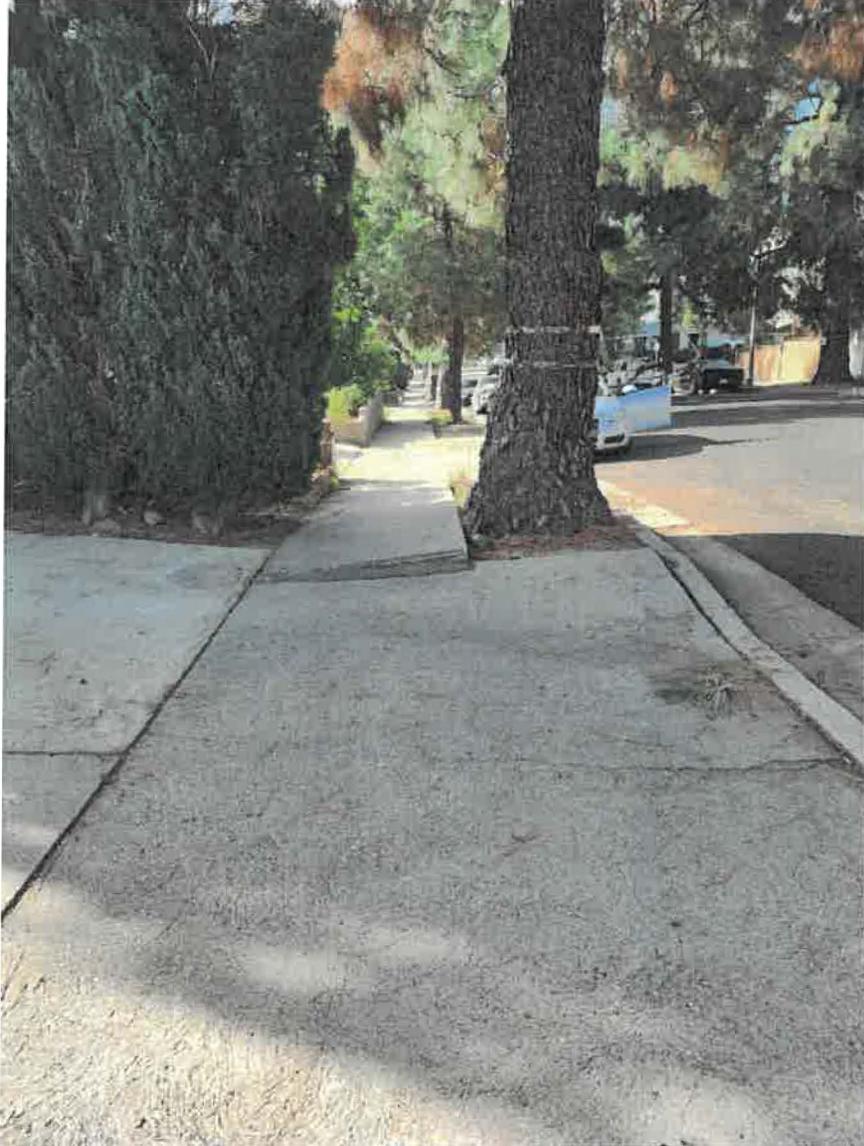
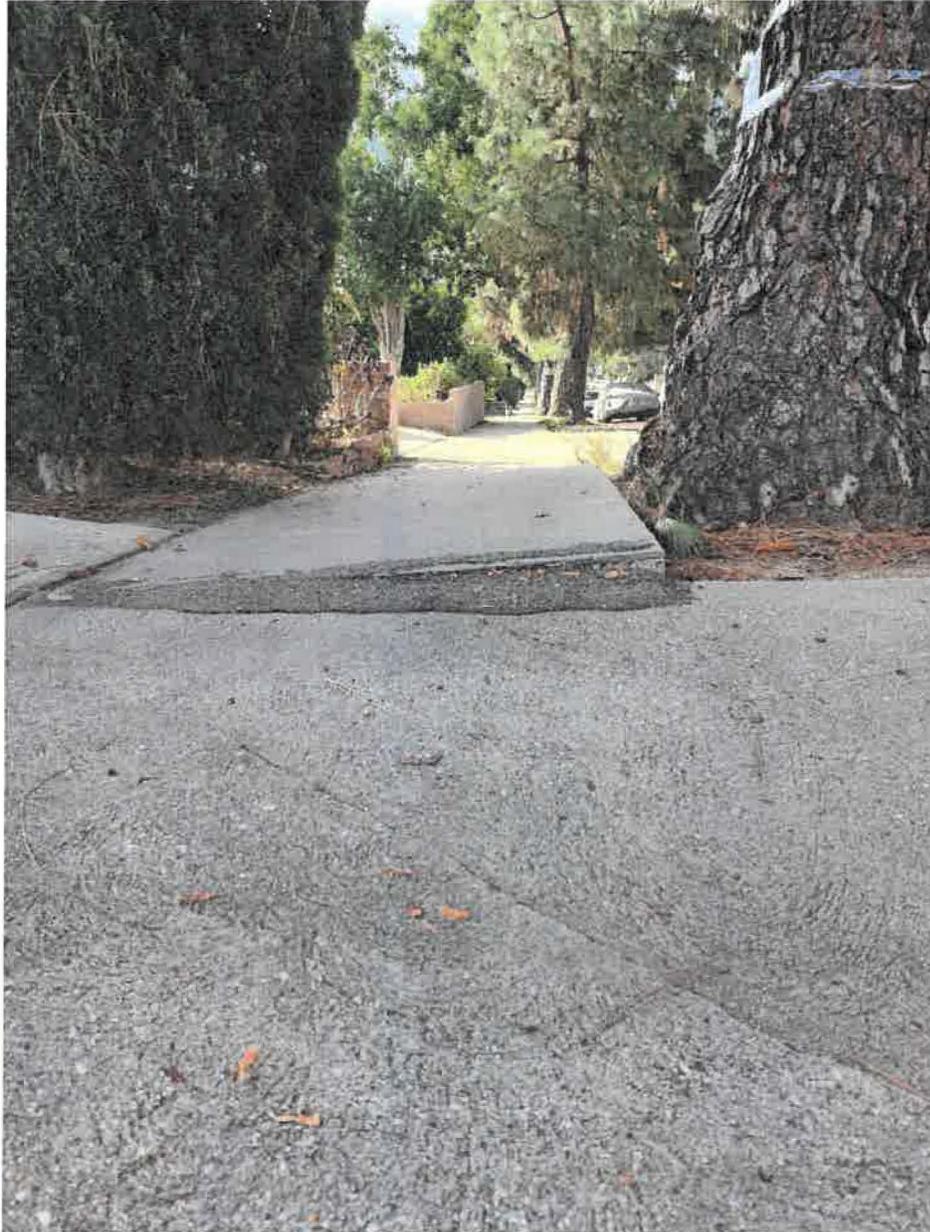
10146 Yolanda Ave (F1)

Proposed to be Removed - UFD cannot ramp over the pine tree roots since the prevailing grade of the street exceeds 5%. The Canary Island pine has an elevated root flare creating severe off grade sidewalk conditions. Large diameter roots are extending under the existing sidewalk. Excessive/ imprudent amount of roots would require pruning to achieve ADA grade requirements & Certificate Of Compliance. Ramping over roots and sidewalk width reduction have been considered as an effort toward tree-preservation yet would not be sufficient due to the extent of repairs surrounding this parkway tree. Root pruning of critical roots will render the trees unstable. Removal is recommended as the best course of action. This genus of trees and its inherent intolerance to root-pruning is the primary factor in UFDs recommendation that no anchoring roots shall be severed at time of Demolition/construction.

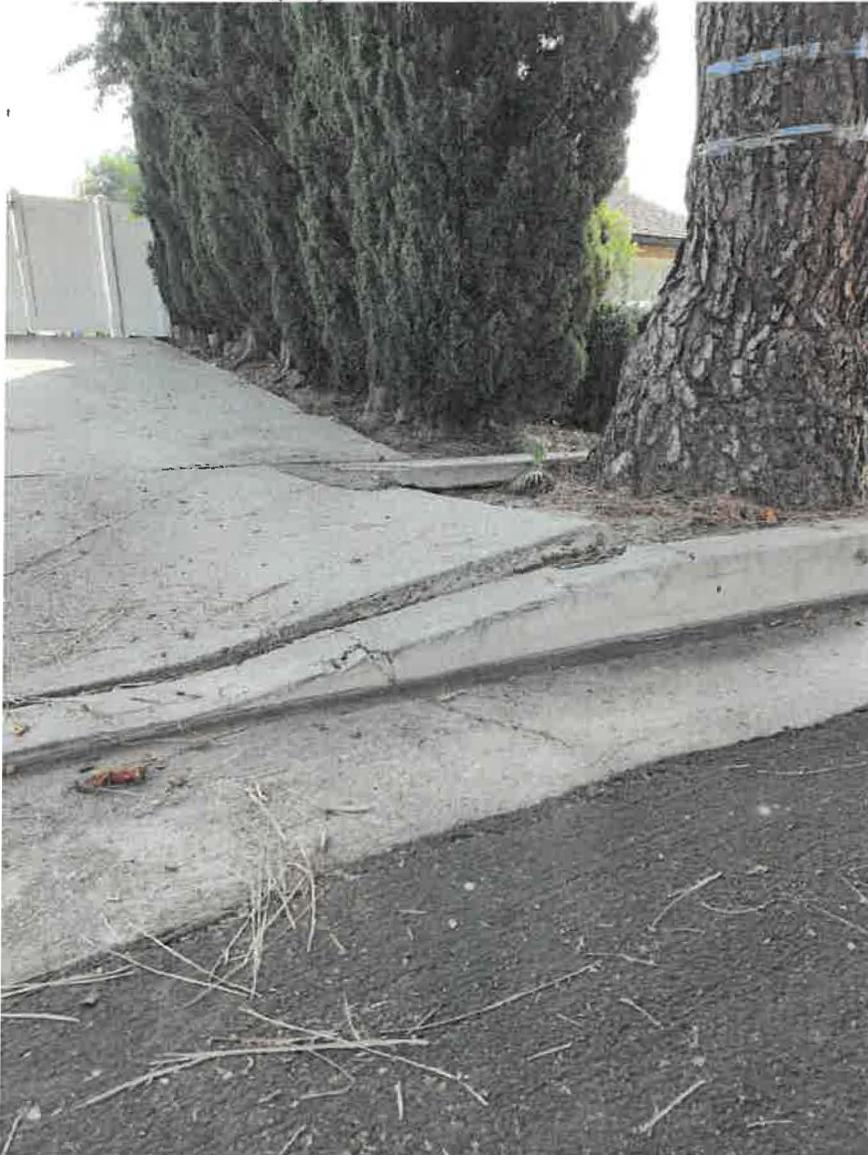
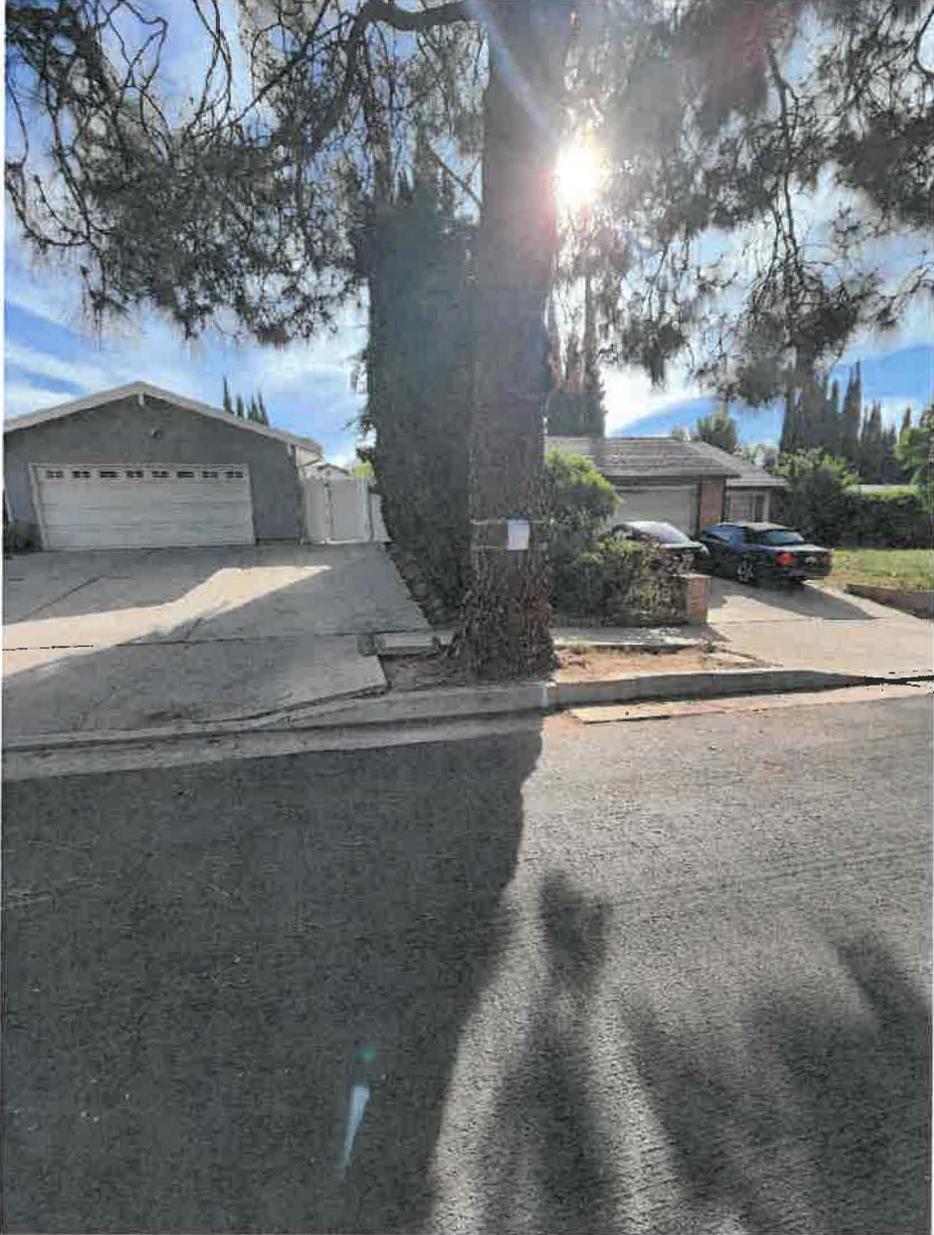
10146 Yolanda Ave (F1)

Proposed to be Removed - UFD cannot ramp over the pine tree roots since the prevailing grade of the street exceeds 5%. The Canary Island pine has an elevated root flare creating severe off grade sidewalk conditions. Large diameter roots are extending under the existing sidewalk. Excessive/ imprudent amount of roots would require pruning to achieve ADA grade requirements & Certificate Of Compliance. Ramping over roots and sidewalk width reduction have been considered as an effort toward tree-preservation yet would not be sufficient due to the extent of repairs surrounding this parkway tree. Root pruning of critical roots will render the trees unstable. Removal is recommended as the best course of action. This genus of trees and its inherent intolerance to root-pruning is the primary factor in UFDs recommendation that no anchoring roots shall be severed at time of Demolition/construction.

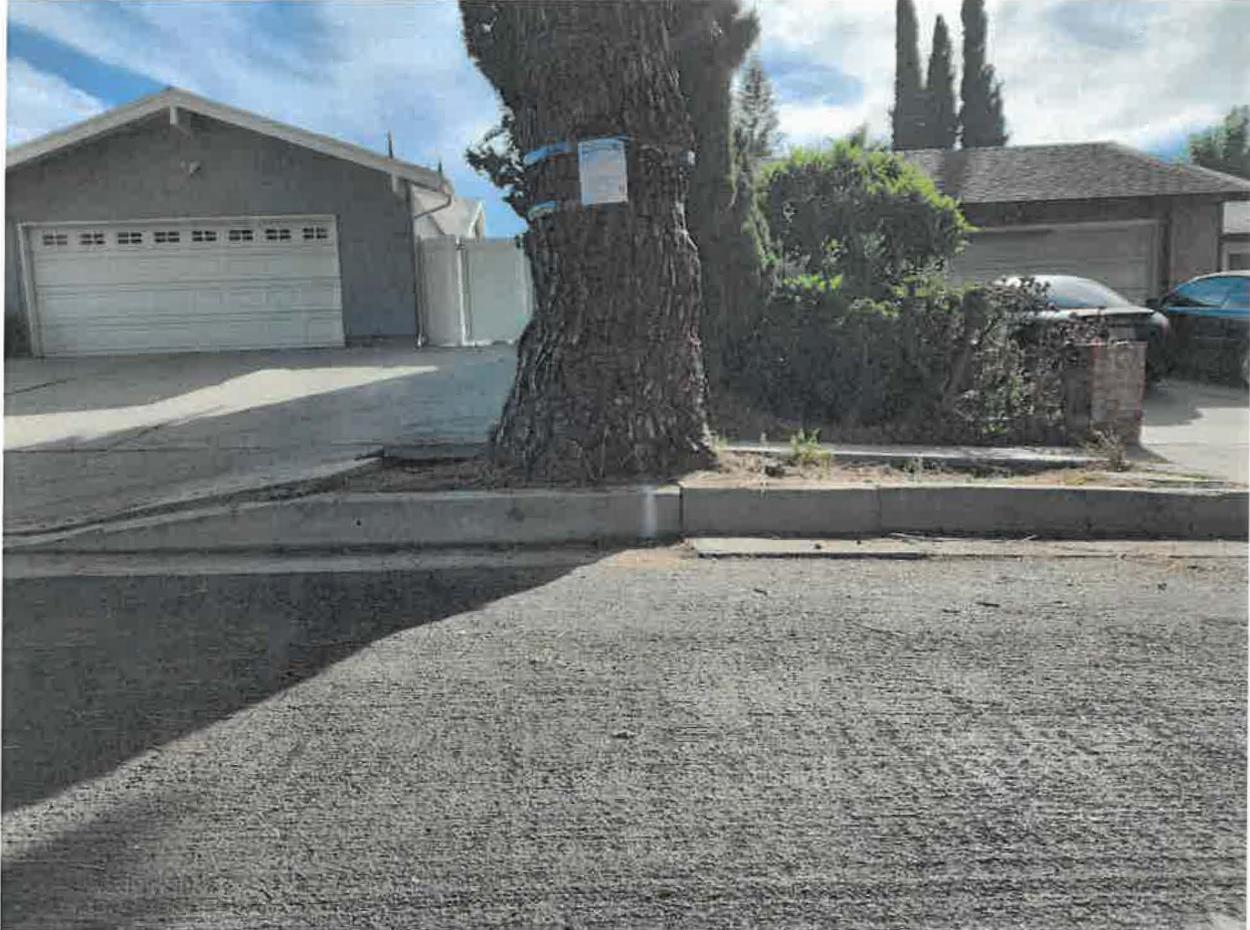
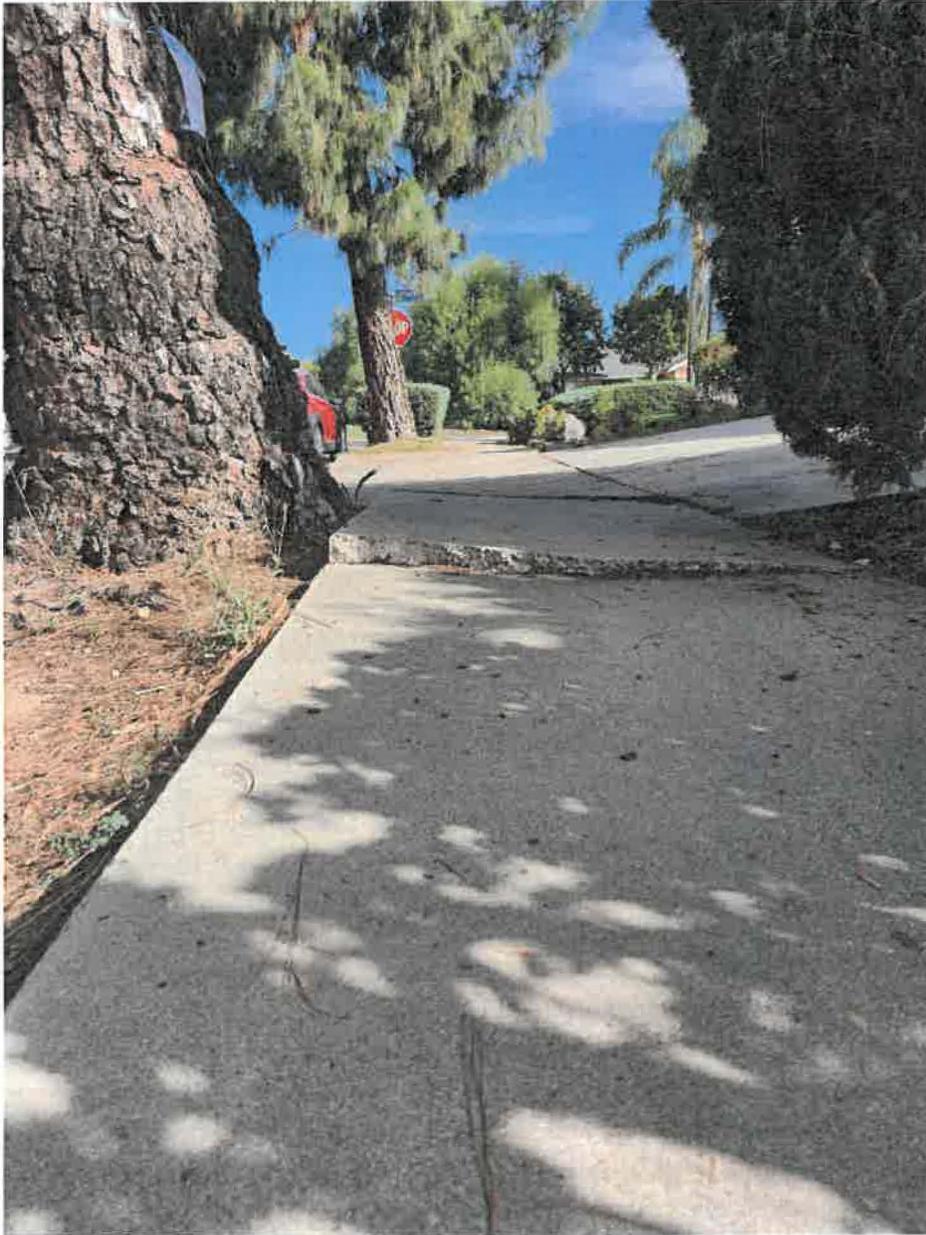
10146 Yolanda Ave (F1)

Proposed to be Removed - UFD cannot ramp over the pine tree roots since the prevailing grade of the street exceeds 5%. The Canary Island pine has an elevated root flare creating severe off grade sidewalk conditions. Large diameter roots are extending under the existing sidewalk. Excessive/ imprudent amount of roots would require pruning to achieve ADA grade requirements & Certificate Of Compliance. Ramping over roots and sidewalk width reduction have been considered as an effort toward tree-preservation yet would not be sufficient due to the extent of repairs surrounding this parkway tree. Root pruning of critical roots will render the trees unstable. Removal is recommended as the best course of action. This genus of trees and its inherent intolerance to root-pruning is the primary factor in UFDs recommendation that no anchoring roots shall be severed at time of Demolition/construction.

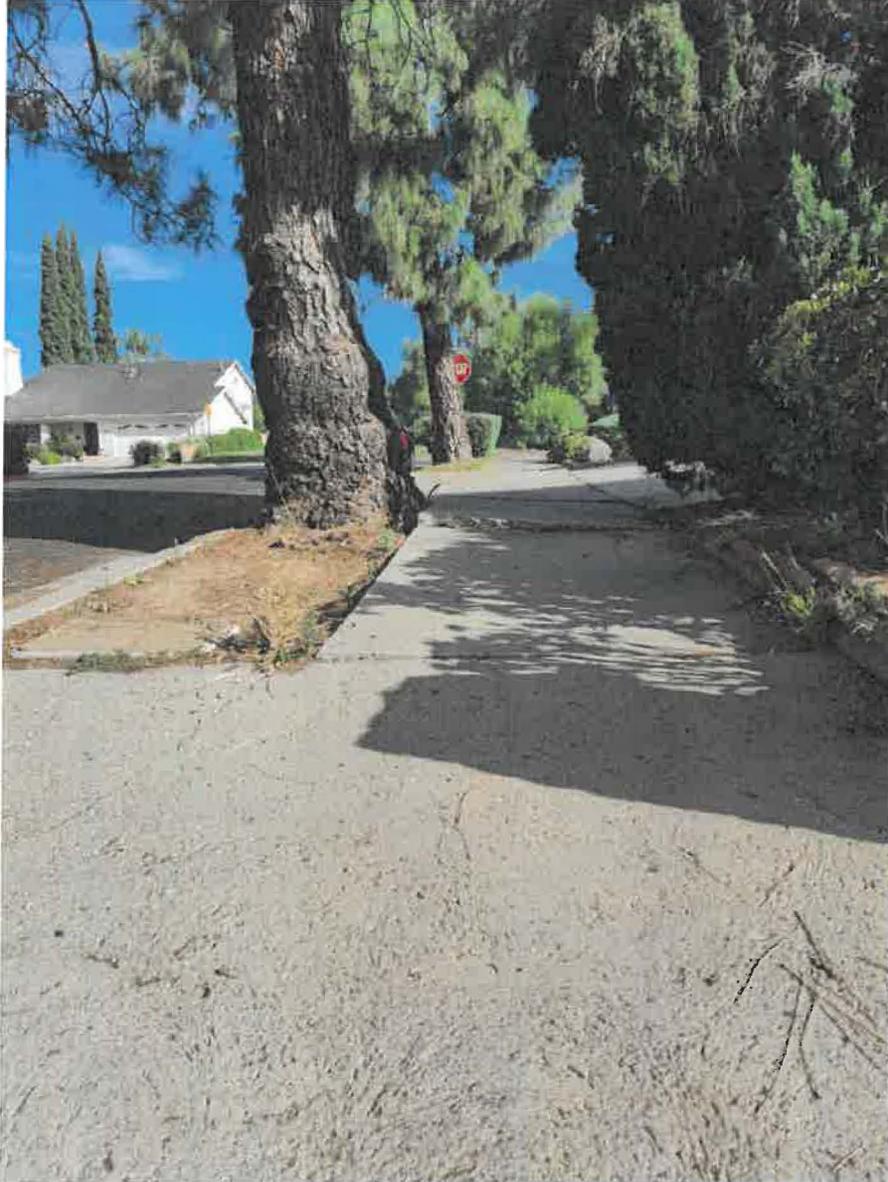
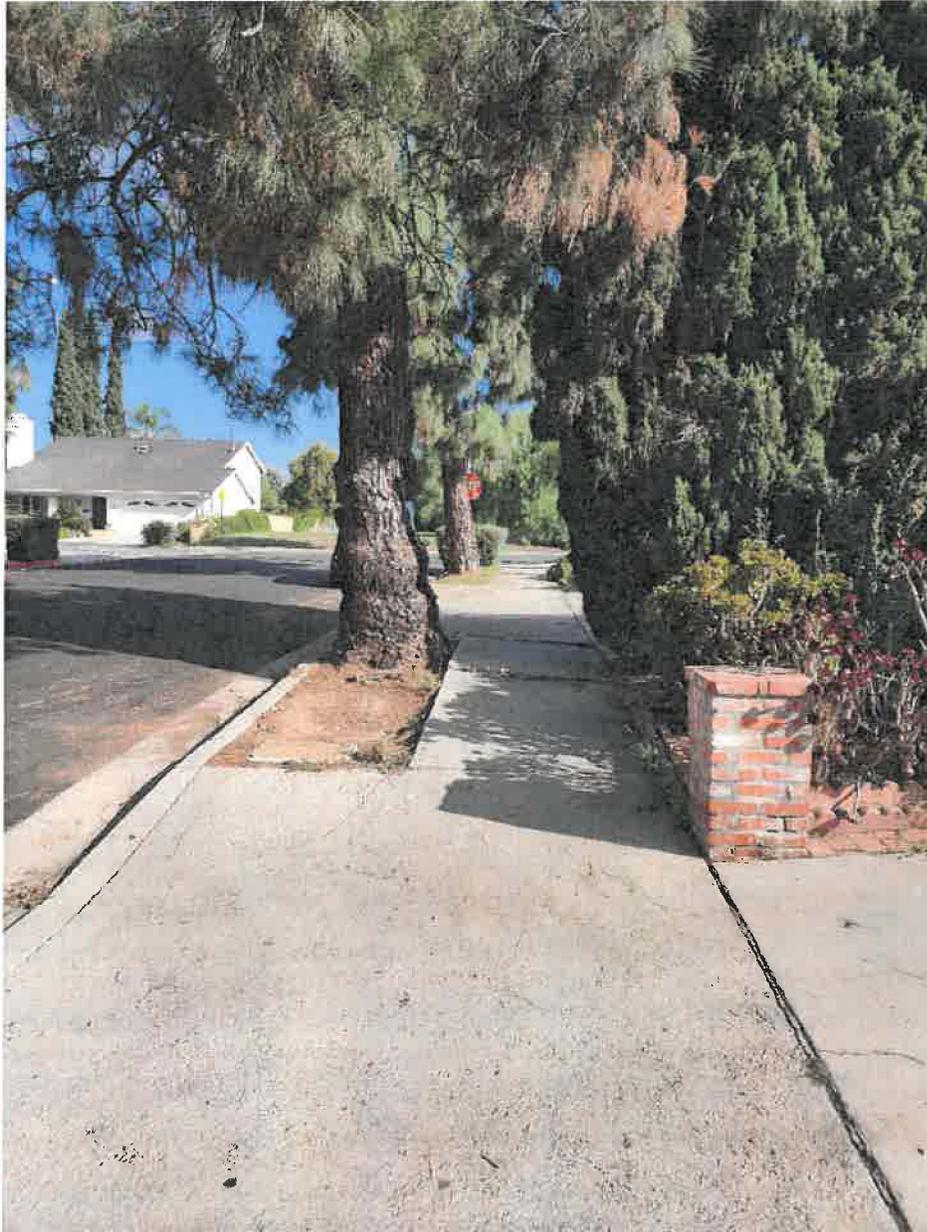
10146 Yolanda Ave (F1)

Proposed to be Removed - UFD cannot ramp over the pine tree roots since the prevailing grade of the street exceeds 5%. The Canary Island pine has an elevated root flare creating severe off grade sidewalk conditions. Large diameter roots are extending under the existing sidewalk. Excessive/ imprudent amount of roots would require pruning to achieve ADA grade requirements & Certificate Of Compliance. Ramping over roots and sidewalk width reduction have been considered as an effort toward tree-preservation yet would not be sufficient due to the extent of repairs surrounding this parkway tree. Root pruning of critical roots will render the trees unstable. Removal is recommended as the best course of action. This genus of trees and its inherent intolerance to root-pruning is the primary factor in UFDs recommendation that no anchoring roots shall be severed at time of Demolition/construction.

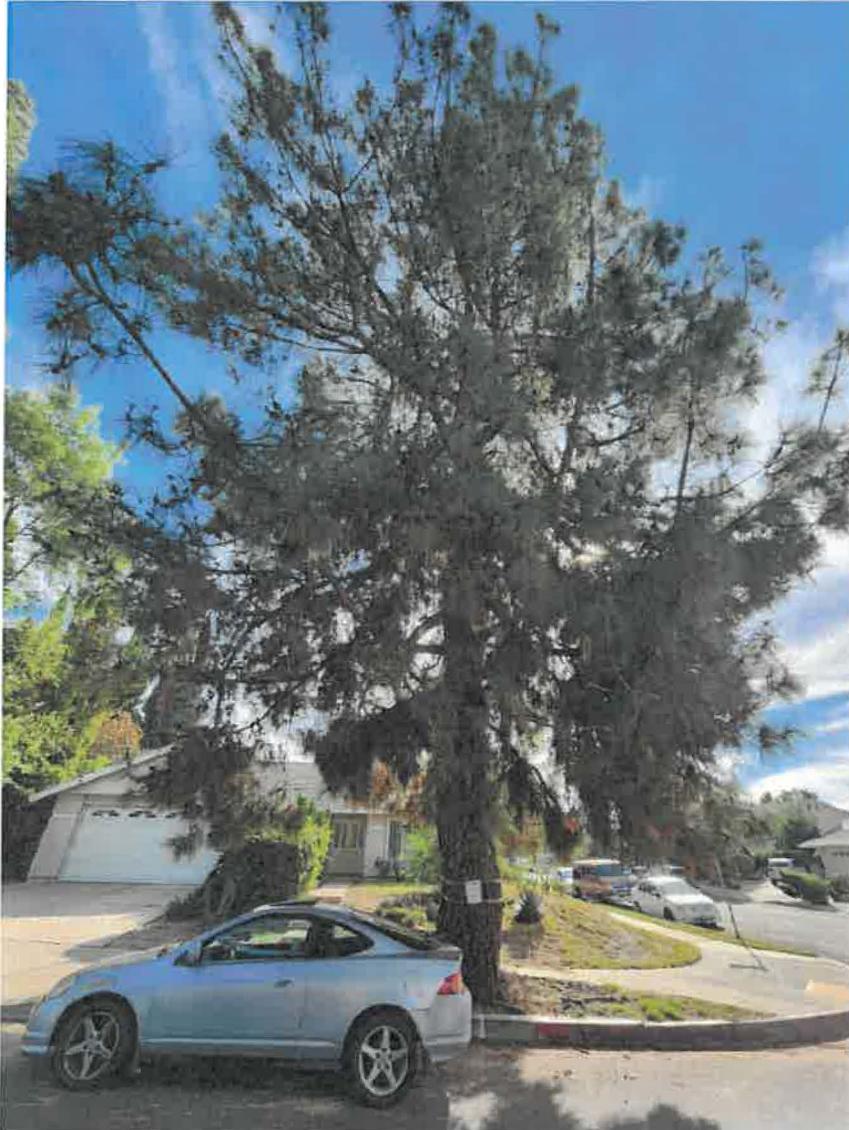
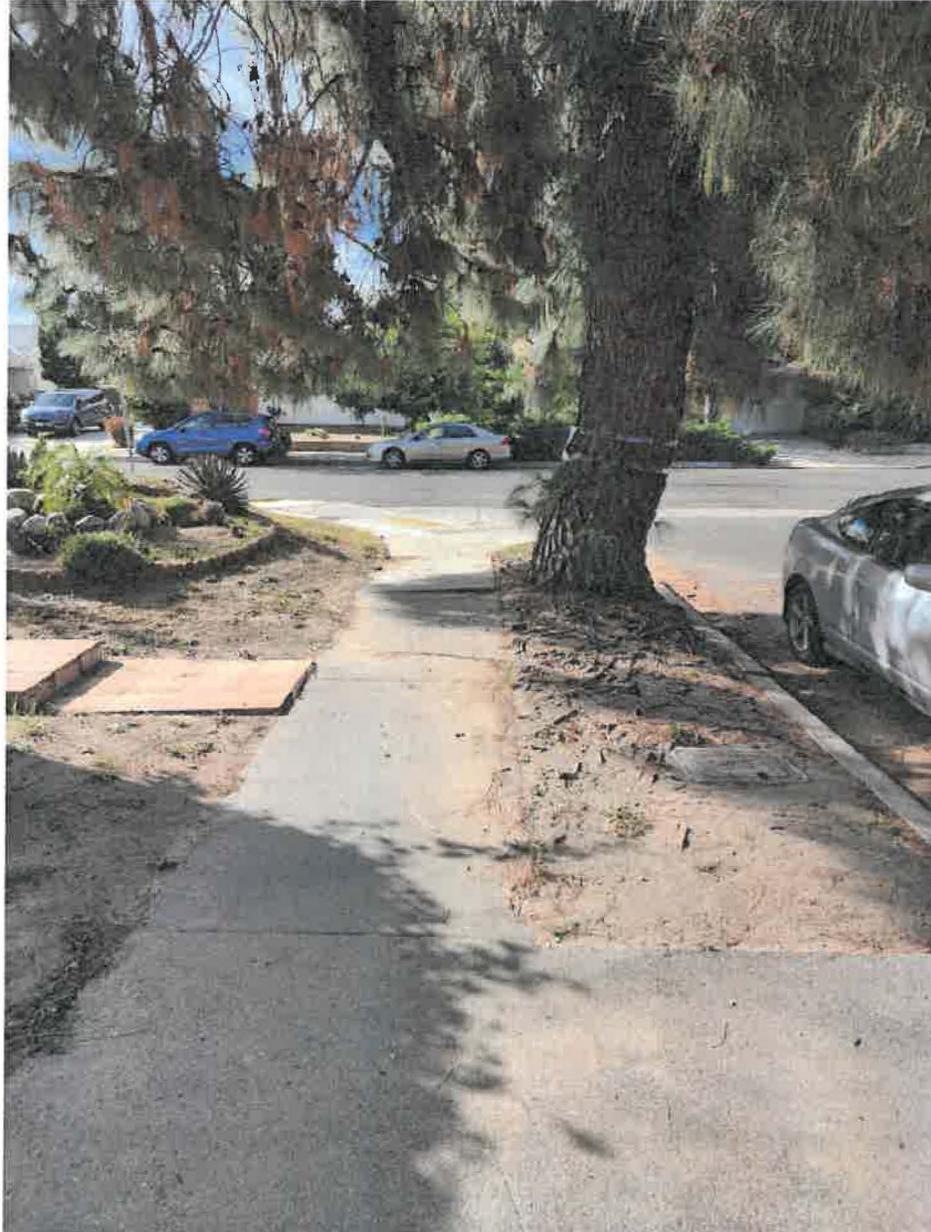
10100 Gladbeck Ave (F1)

Proposed to be Removed - UFD cannot ramp over this Canary Island pine tree, tree roots since the prevailing grade will drop 5" in. to repair adjacent curb ramp to ADA standards. This Canary Island pine has an elevated root flare creating a severe sidewalk off grade conditions. Large diameter roots are extending under the existing sidewalk and an excessive/ imprudent amount of roots would require pruning to achieve ADA grade requirements & Certificate Of Compliance. Ramping over roots and sidewalk width reduction have been considered as an effort toward tree-preservation yet would not be sufficient due to the extent of repairs surrounding this parkway tree. Root pruning of critical roots will render the trees unstable. Therefore, Removal is recommended as the best course of action. This genus of tree and its inherent intolerance to root-pruning is the primary factor in UFDs recommendation for tree removal.

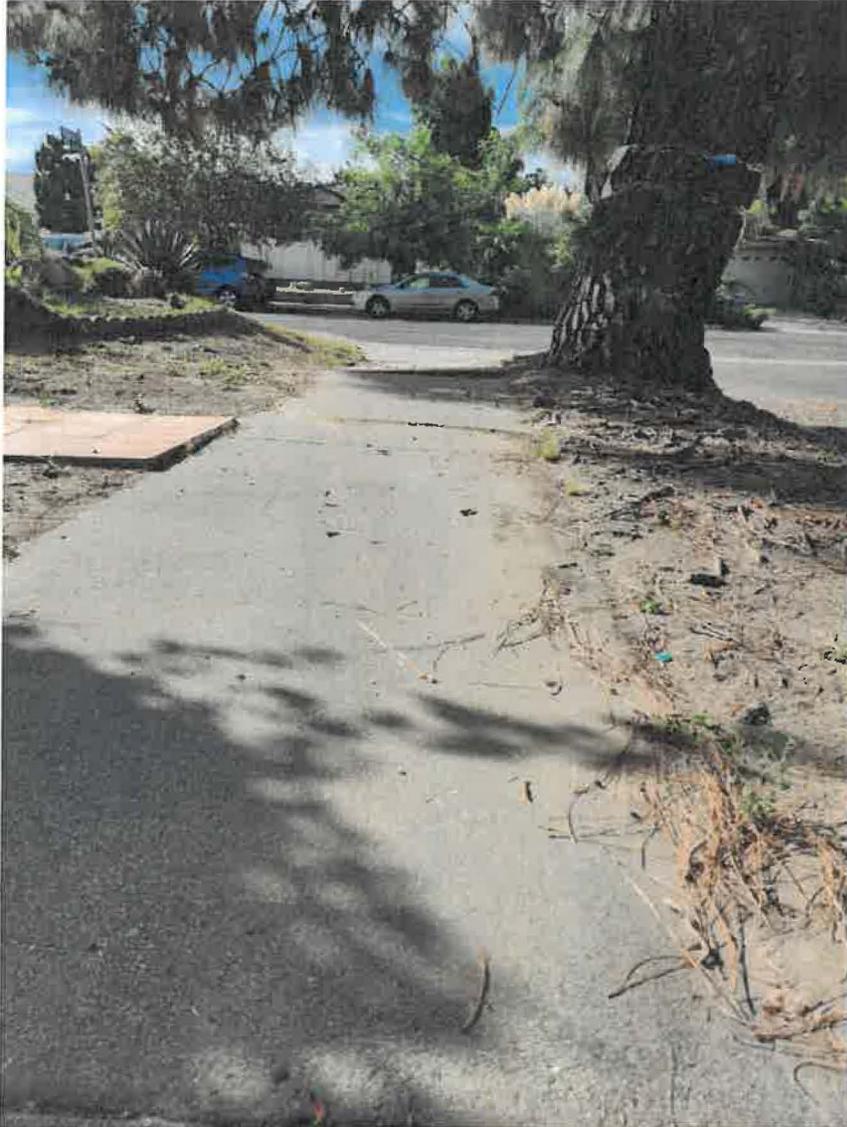
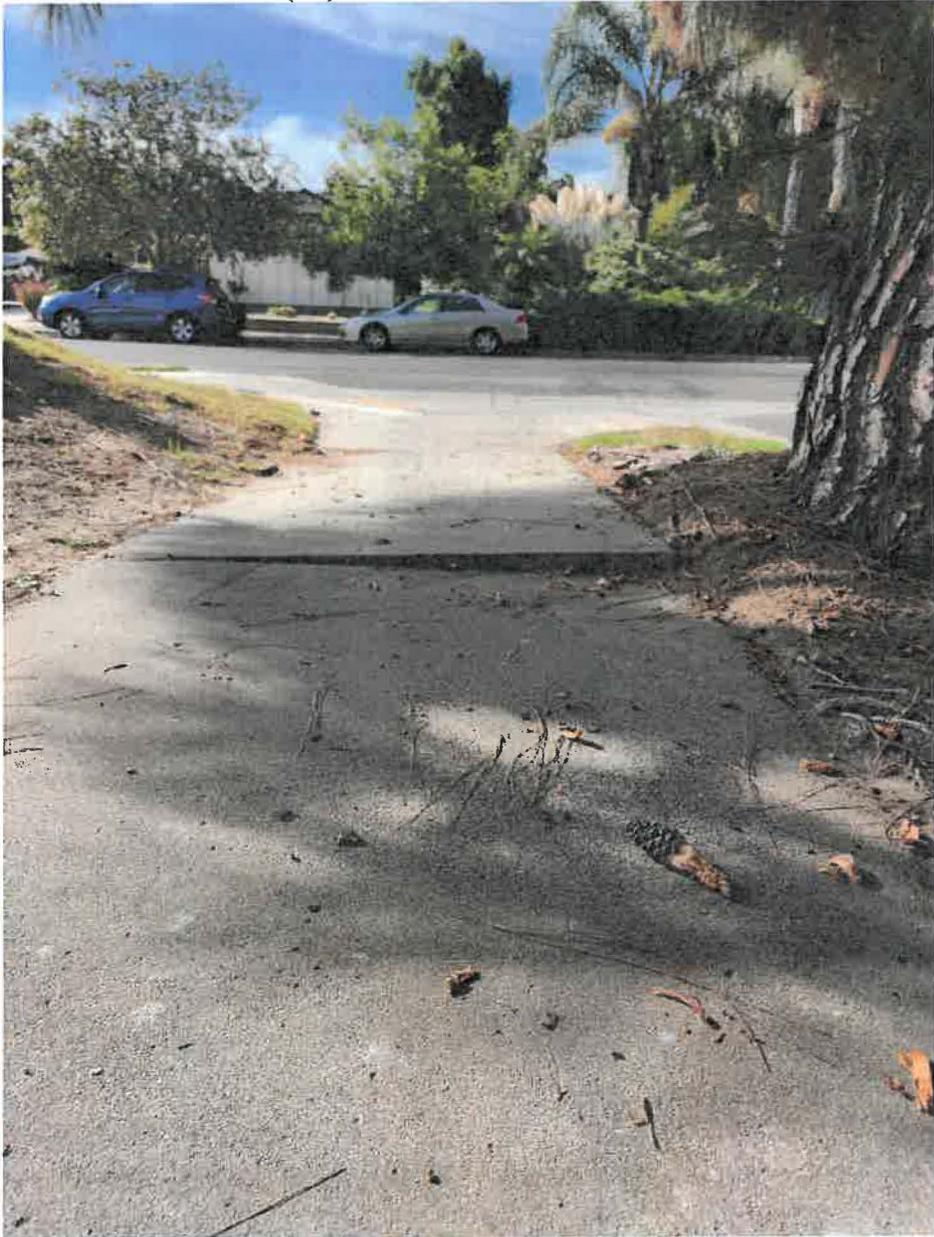
10100 Gladbeck Ave (F1)

Proposed to be Removed - UFD cannot ramp over this Canary Island pine tree, tree roots since the prevailing grade will drop 5" in. to repair adjacent curb ramp to ADA standards. This Canary Island pine has an elevated root flare creating a severe sidewalk off grade conditions. Large diameter roots are extending under the existing sidewalk and an excessive/ imprudent amount of roots would require pruning to achieve ADA grade requirements & Certificate Of Compliance. Ramping over roots and sidewalk width reduction have been considered as an effort toward tree-preservation yet would not be sufficient due to the extent of repairs surrounding this parkway tree. Root pruning of critical roots will render the trees unstable. Therefore, Removal is recommended as the best course of action. This genus of tree and its inherent intolerance to root-pruning is the primary factor in UFDs recommendation for tree removal.

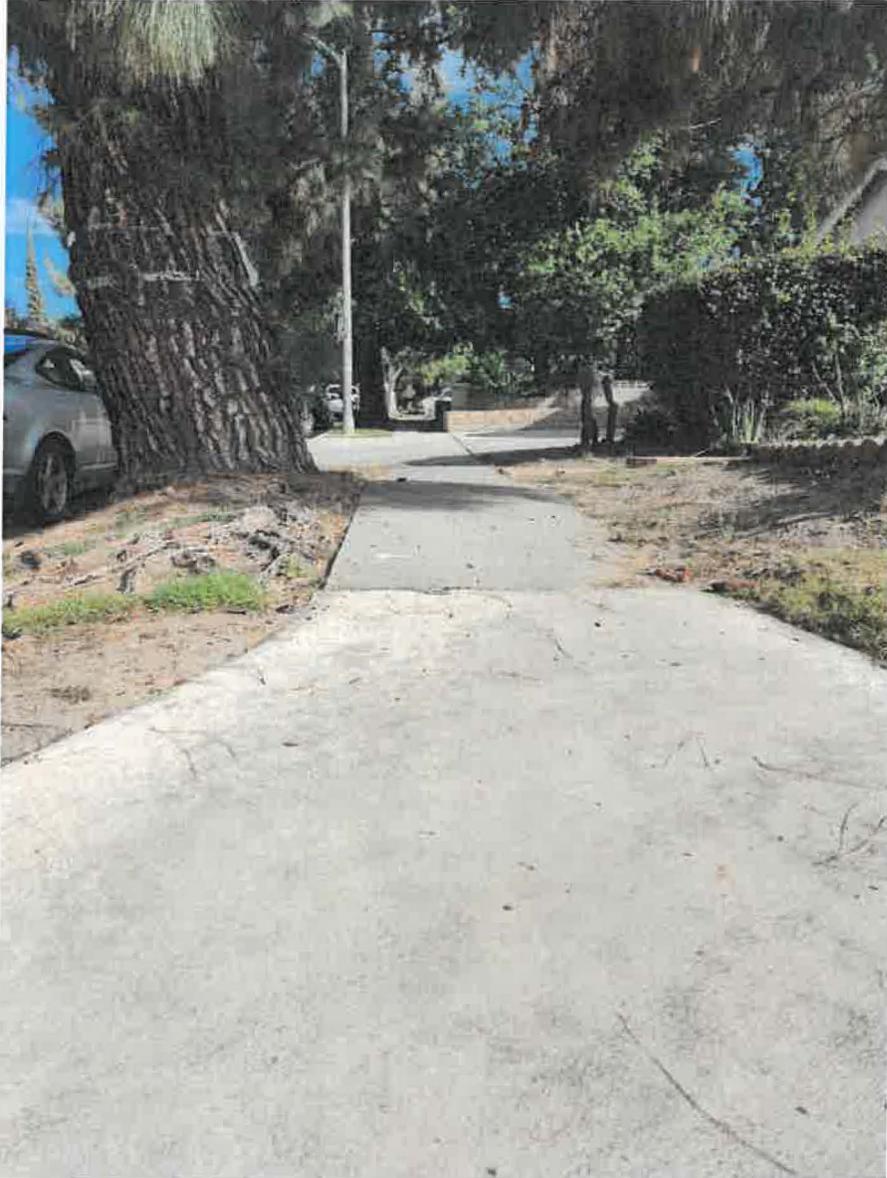
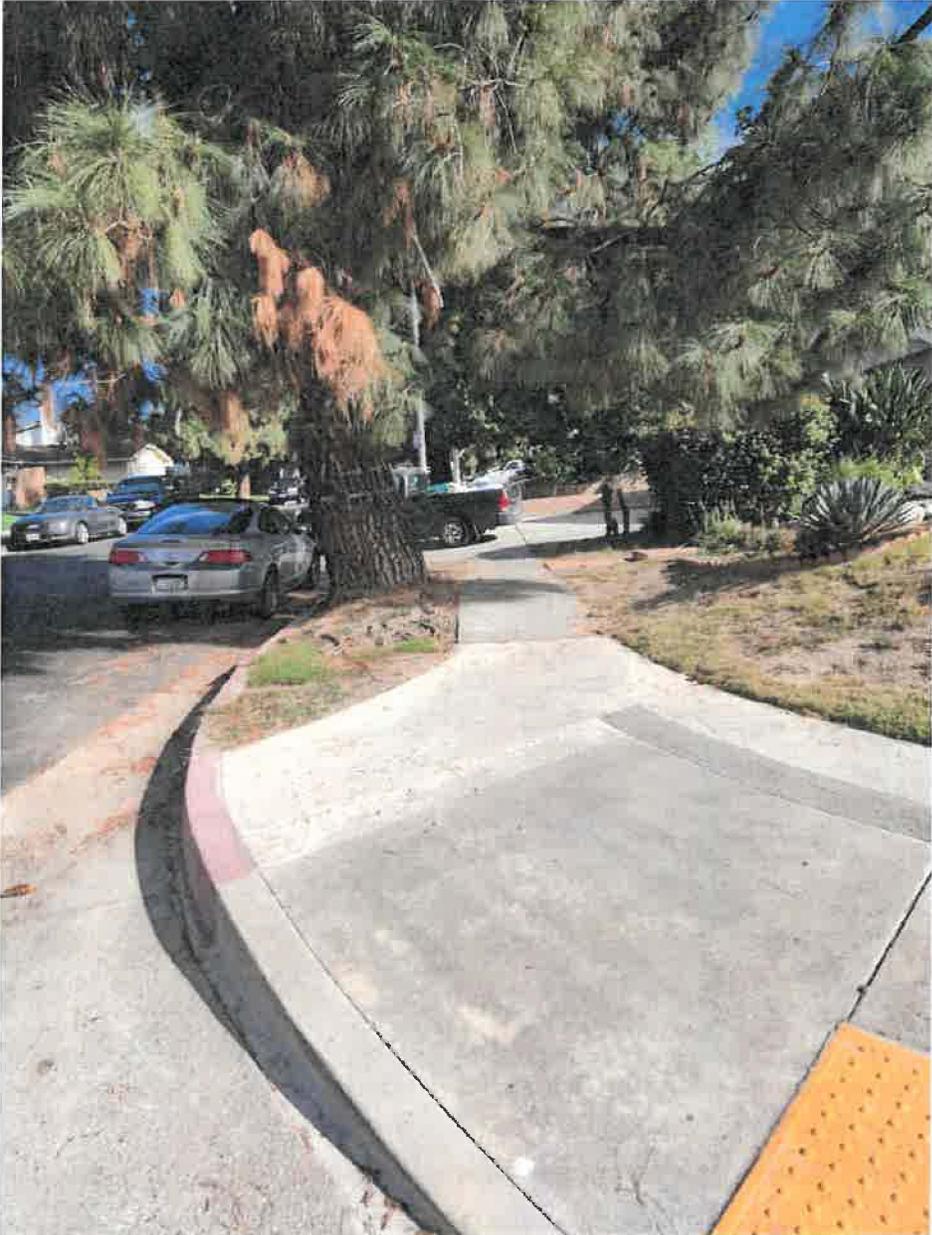
10100 Gladbeck Ave (F1)

Proposed to be Removed - UFD cannot ramp over this Canary Island pine tree, tree roots since the prevailing grade will drop 5" in. to repair adjacent curb ramp to ADA standards. This Canary Island pine has an elevated root flare creating a severe sidewalk off grade conditions. Large diameter roots are extending under the existing sidewalk and an excessive/ imprudent amount of roots would require pruning to achieve ADA grade requirements & Certificate Of Compliance. Ramping over roots and sidewalk width reduction have been considered as an effort toward tree-preservation yet would not be sufficient due to the extent of repairs surrounding this parkway tree. Root pruning of critical roots will render the trees unstable. Therefore, Removal is recommended as the best course of action. This genus of tree and its inherent intolerance to root-pruning is the primary factor in UFDs recommendation for tree removal.

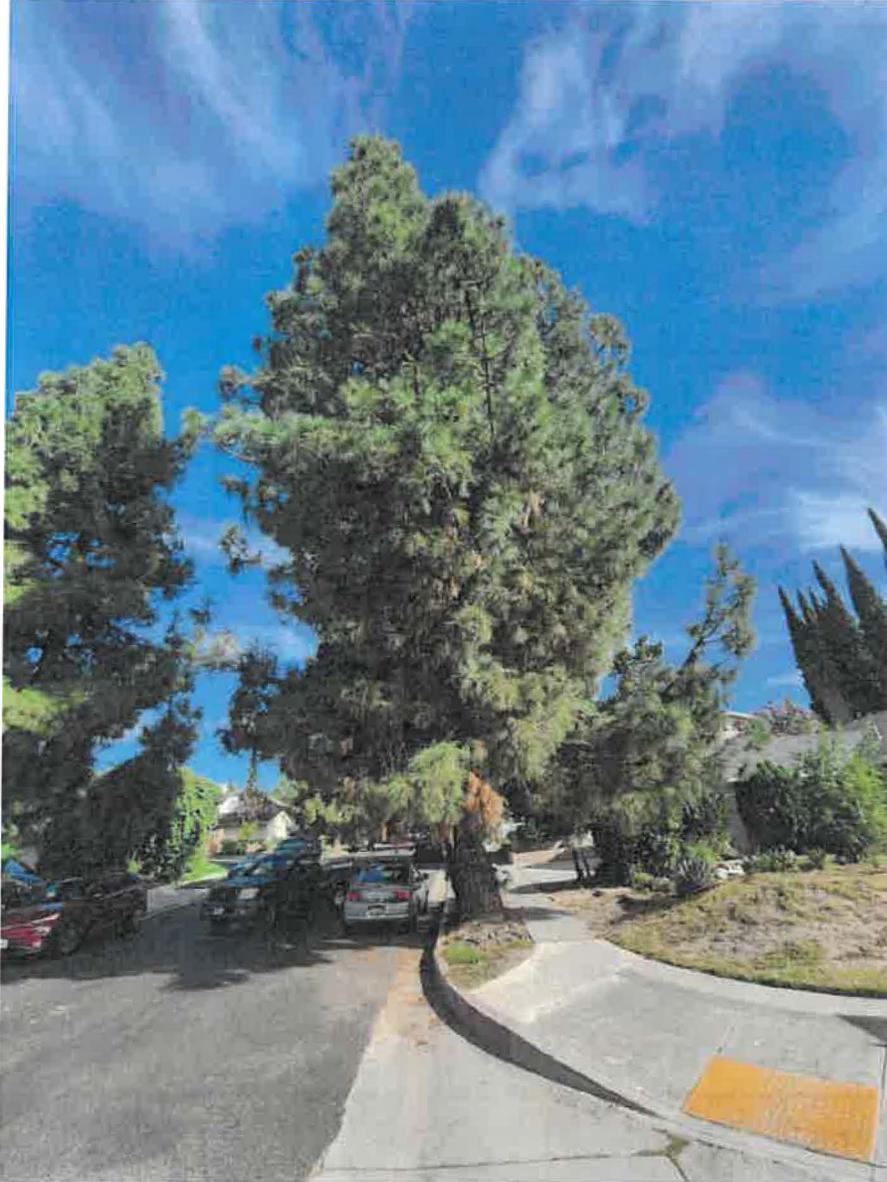
10100 Gladbeck Ave (F1)

Proposed to be Removed - UFD cannot ramp over this Canary Island pine tree, tree roots since the prevailing grade will drop 5" in. to repair adjacent curb ramp to ADA standards. This Canary Island pine has an elevated root flare creating a severe sidewalk off grade conditions. Large diameter roots are extending under the existing sidewalk and an excessive/ imprudent amount of roots would require pruning to achieve ADA grade requirements & Certificate Of Compliance. Ramping over roots and sidewalk width reduction have been considered as an effort toward tree-preservation yet would not be sufficient due to the extent of repairs surrounding this parkway tree. Root pruning of critical roots will render the trees unstable. Therefore, Removal is recommended as the best course of action. This genus of tree and its inherent intolerance to root-pruning is the primary factor in UFDs recommendation for tree removal.
