DEPARTMENT OF PUBLIC WORKS
BUREAU OF STREET SERVICES
REPORT NO.1

18700 BLOCK WEST MAYALL AVENUE AND ADJACENT STREETS (BOE – 68) – CITYWIDE SIDEWALK REPAIR PROGRAM IN COUNCIL DISTRICT TWELVE REQUEST BOARD OF PUBLIC WORKS TO CONCUR WITH A SIDEWALK REPAIR PROJECT AND APPROVE THE REMOVAL OF SEVEN CANARY ISLAND PINE (PINUS CANARIENSIS) TREES FOR THE RECONSTRUCTION OF THE NON-ADA COMPLIANT PUBLIC SIDEWALK. TREE REPLACEMENTS ARE REQUIRED.

TRANSMITTAL NO. 5

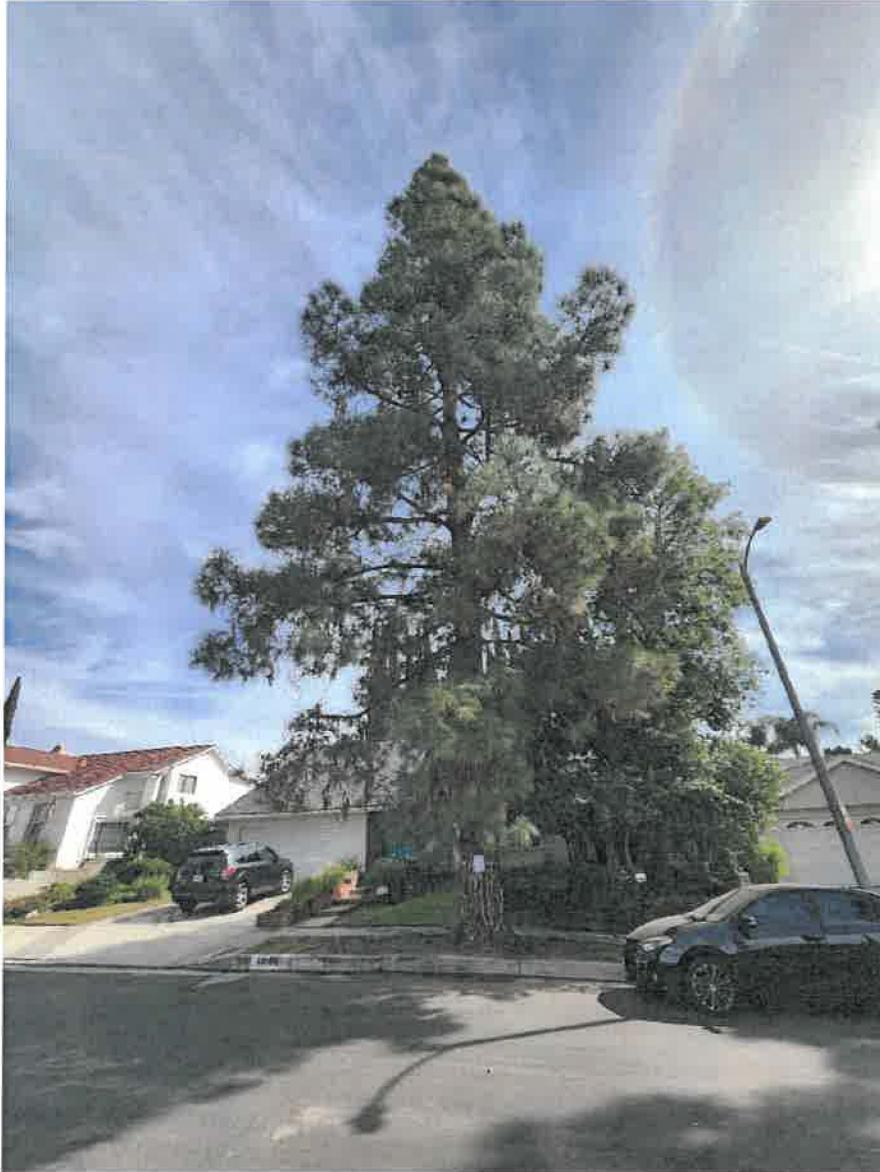
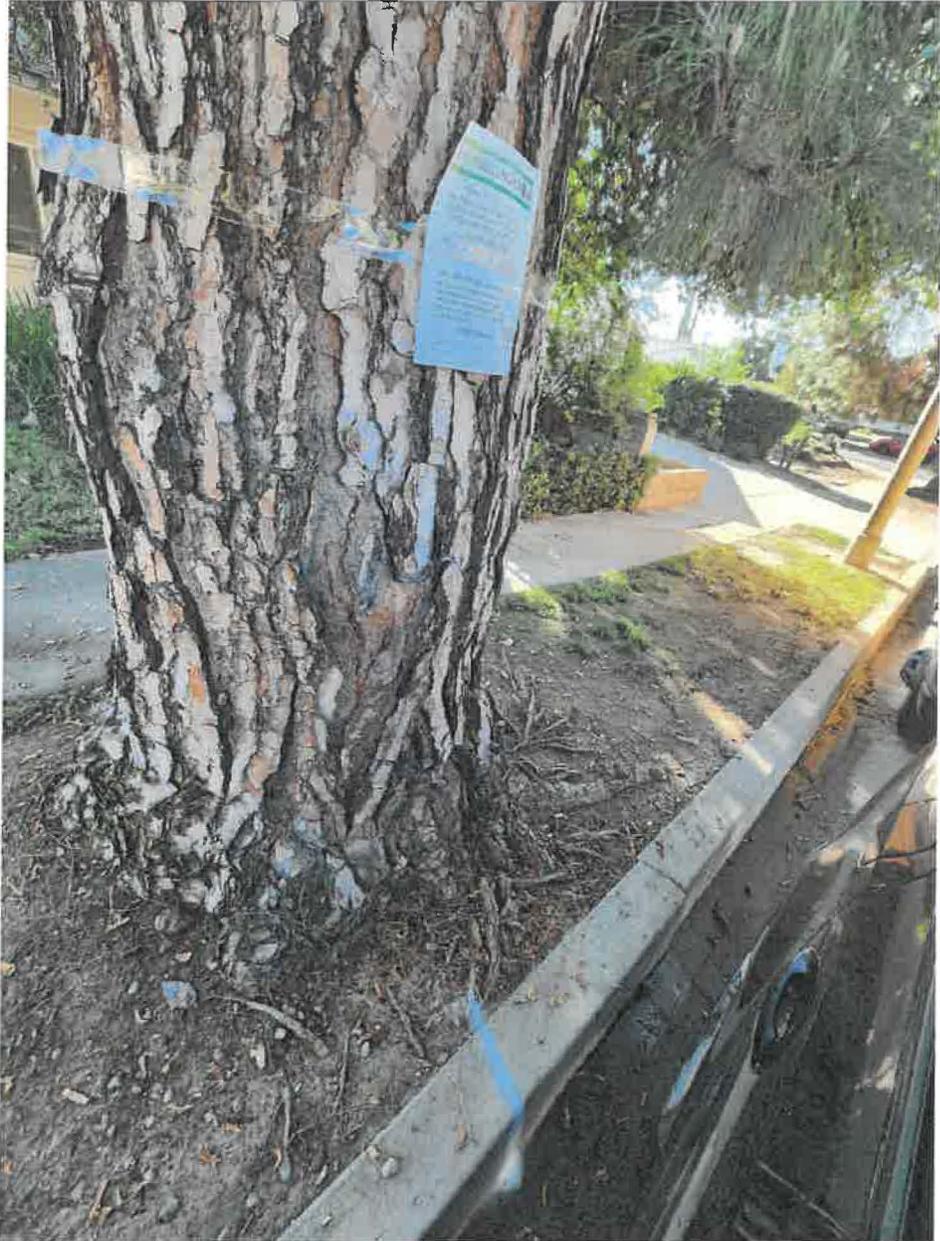
10108 GLADBECK AVE (F1)

Proposed to be Removed - UFD cannot ramp over the pine tree roots since the prevailing grade of the street exceeds 5%. The Canary Island pine has an elevated root flare creating severe off grade sidewalk conditions. Large diameter roots are extending under the existing sidewalk. Excessive/ imprudent amount of roots would require pruning to achieve ADA grade requirements & Certificate Of Compliance. Ramping over roots and sidewalk width reduction have been considered as an effort toward tree-preservation yet would not be sufficient due to the extent of repairs surrounding this parkway tree. Root pruning of critical roots will render the trees unstable. Removal is recommended as the best course of action. This genus of trees and its inherent intolerance to root-pruning is the primary factor in UFDs recommendation that no anchoring roots shall be severed at time of Demolition/construction.

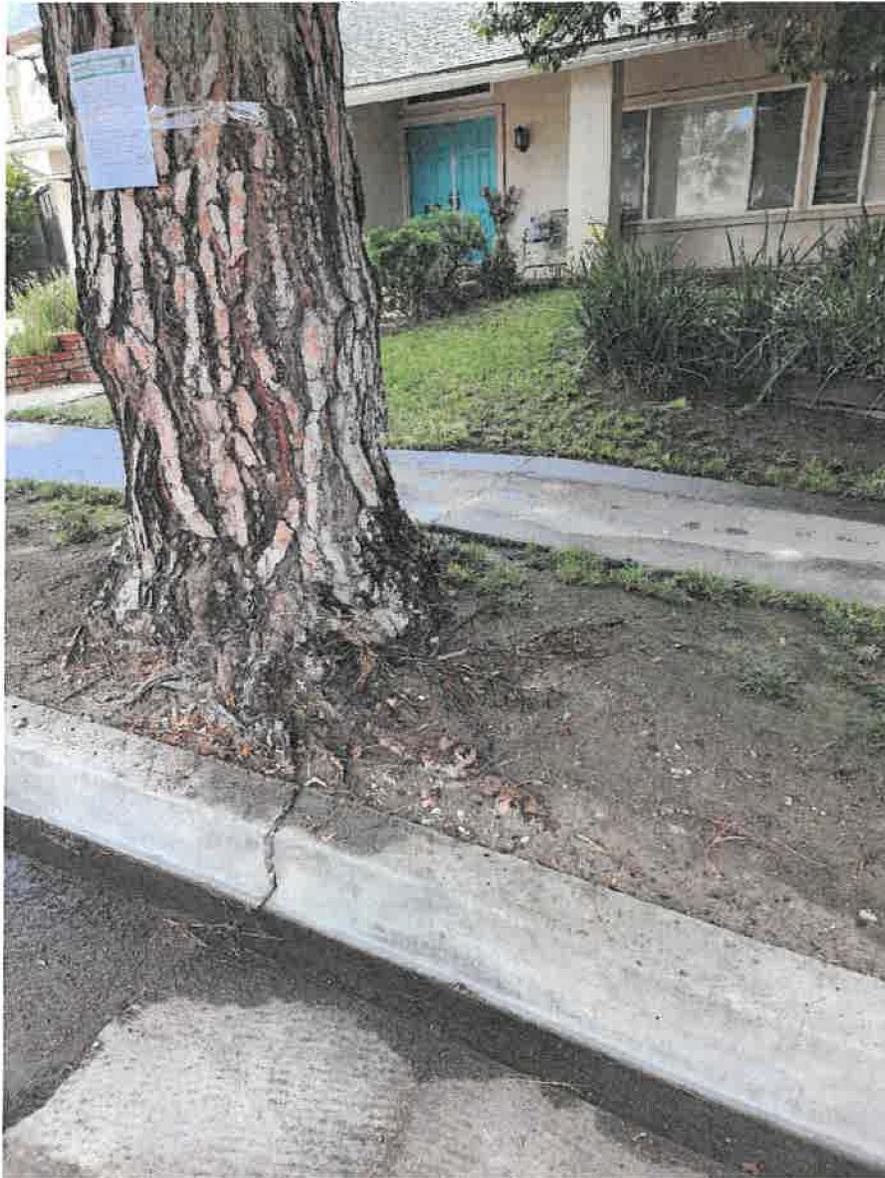
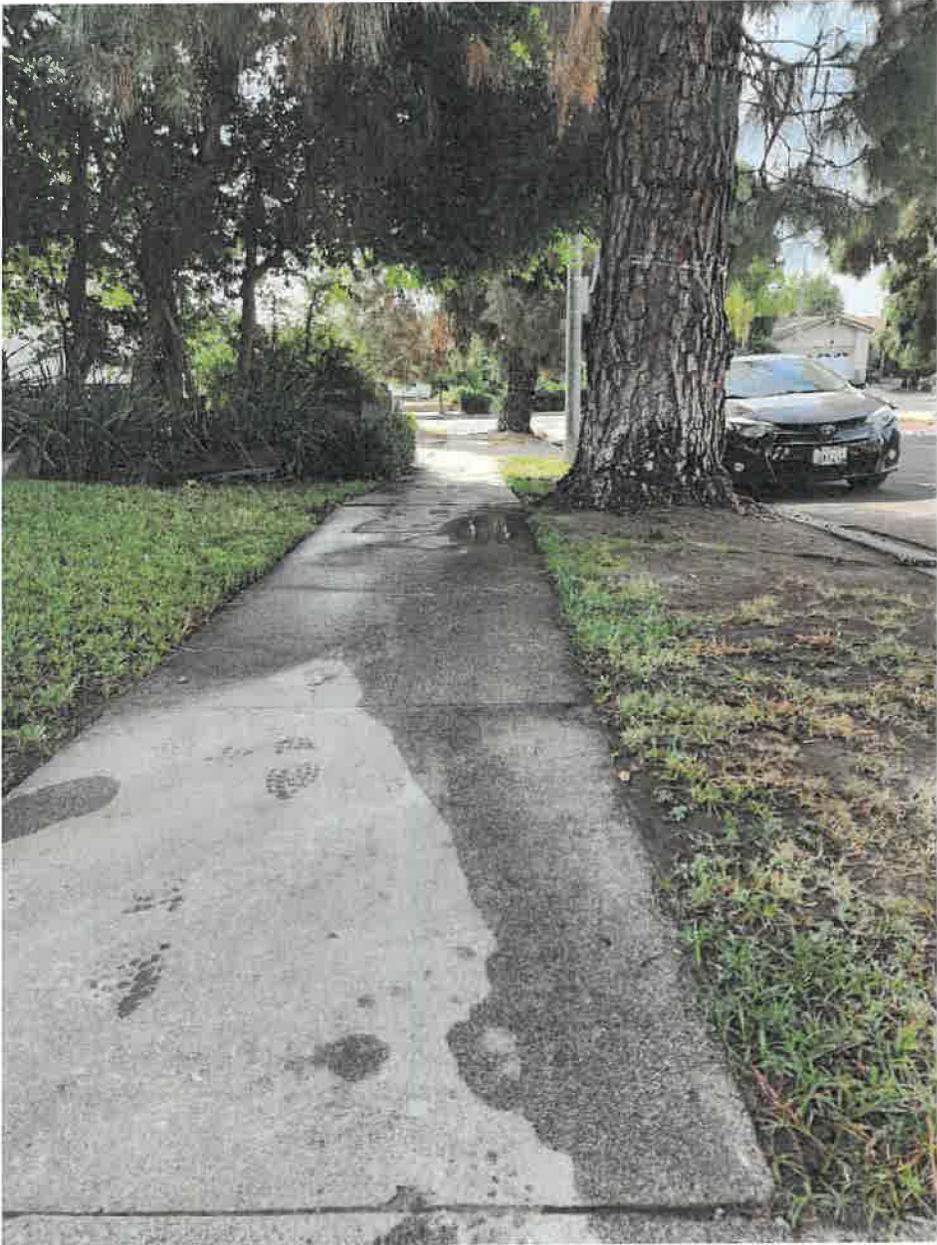
10108 GLADBECK AVE (F1)

Proposed to be Removed - UFD cannot ramp over the pine tree roots since the prevailing grade of the street exceeds 5%. The Canary Island pine has an elevated root flare creating severe off grade sidewalk conditions. Large diameter roots are extending under the existing sidewalk. Excessive/ imprudent amount of roots would require pruning to achieve ADA grade requirements & Certificate Of Compliance. Ramping over roots and sidewalk width reduction have been considered as an effort toward tree-preservation yet would not be sufficient due to the extent of repairs surrounding this parkway tree. Root pruning of critical roots will render the trees unstable. Removal is recommended as the best course of action. This genus of trees and its inherent intolerance to root-pruning is the primary factor in UFDs recommendation that no anchoring roots shall be severed at time of Demolition/construction.

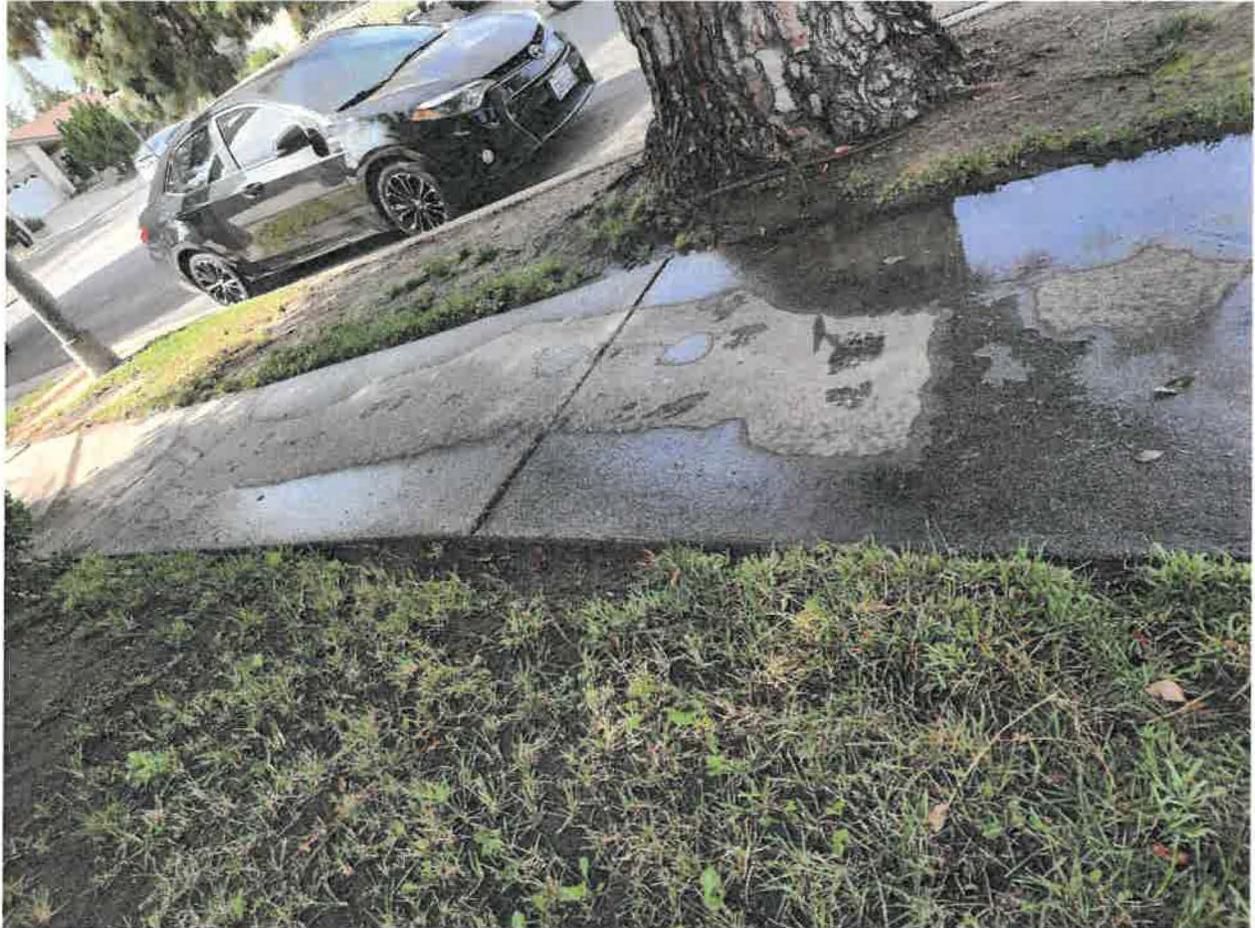
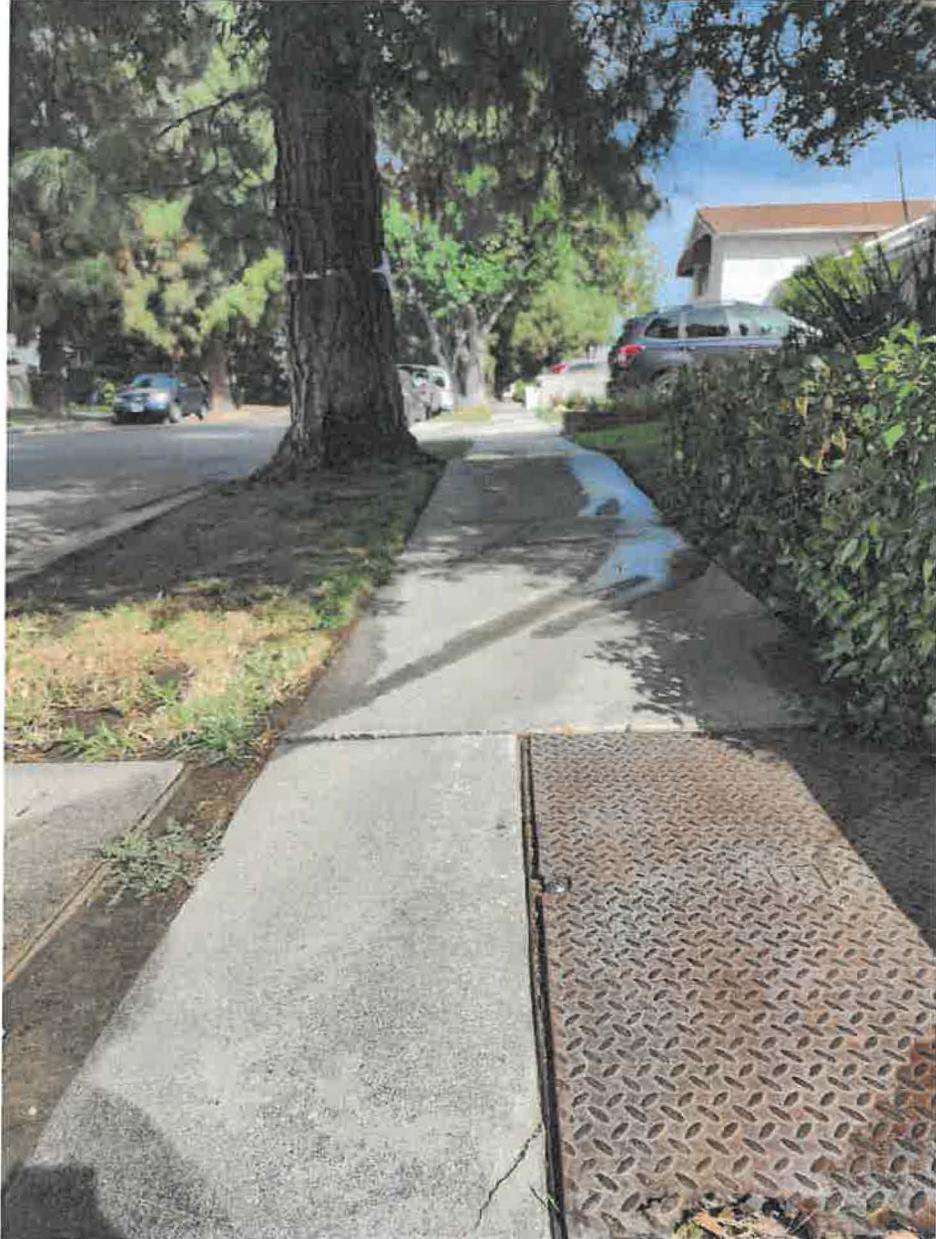
10108 GLADBECK AVE (F1)

Proposed to be Removed - UFD cannot ramp over the pine tree roots since the prevailing grade of the street exceeds 5%. The Canary Island pine has an elevated root flare creating severe off grade sidewalk conditions. Large diameter roots are extending under the existing sidewalk. Excessive/ imprudent amount of roots would require pruning to achieve ADA grade requirements & Certificate Of Compliance. Ramping over roots and sidewalk width reduction have been considered as an effort toward tree-preservation yet would not be sufficient due to the extent of repairs surrounding this parkway tree. Root pruning of critical roots will render the trees unstable. Removal is recommended as the best course of action. This genus of trees and its inherent intolerance to root-pruning is the primary factor in UFDs recommendation that no anchoring roots shall be severed at time of Demolition/construction.

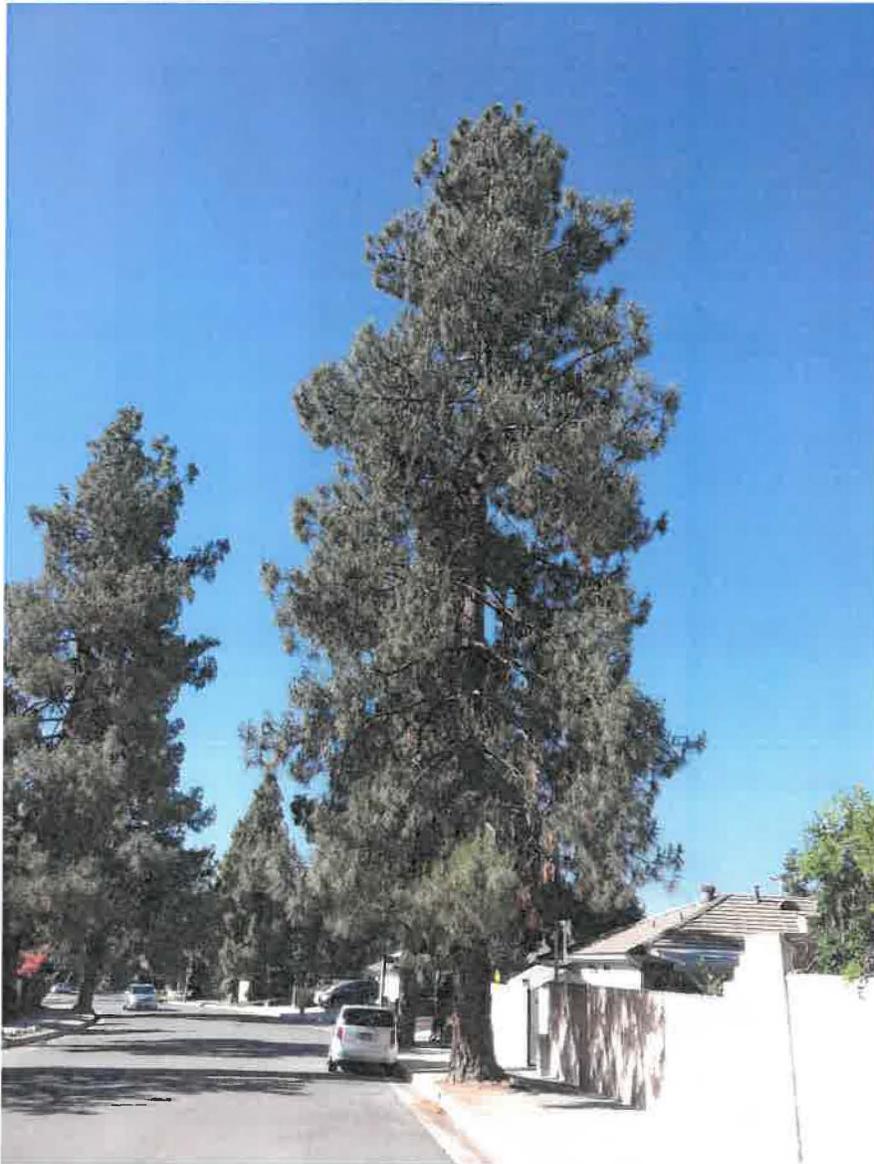
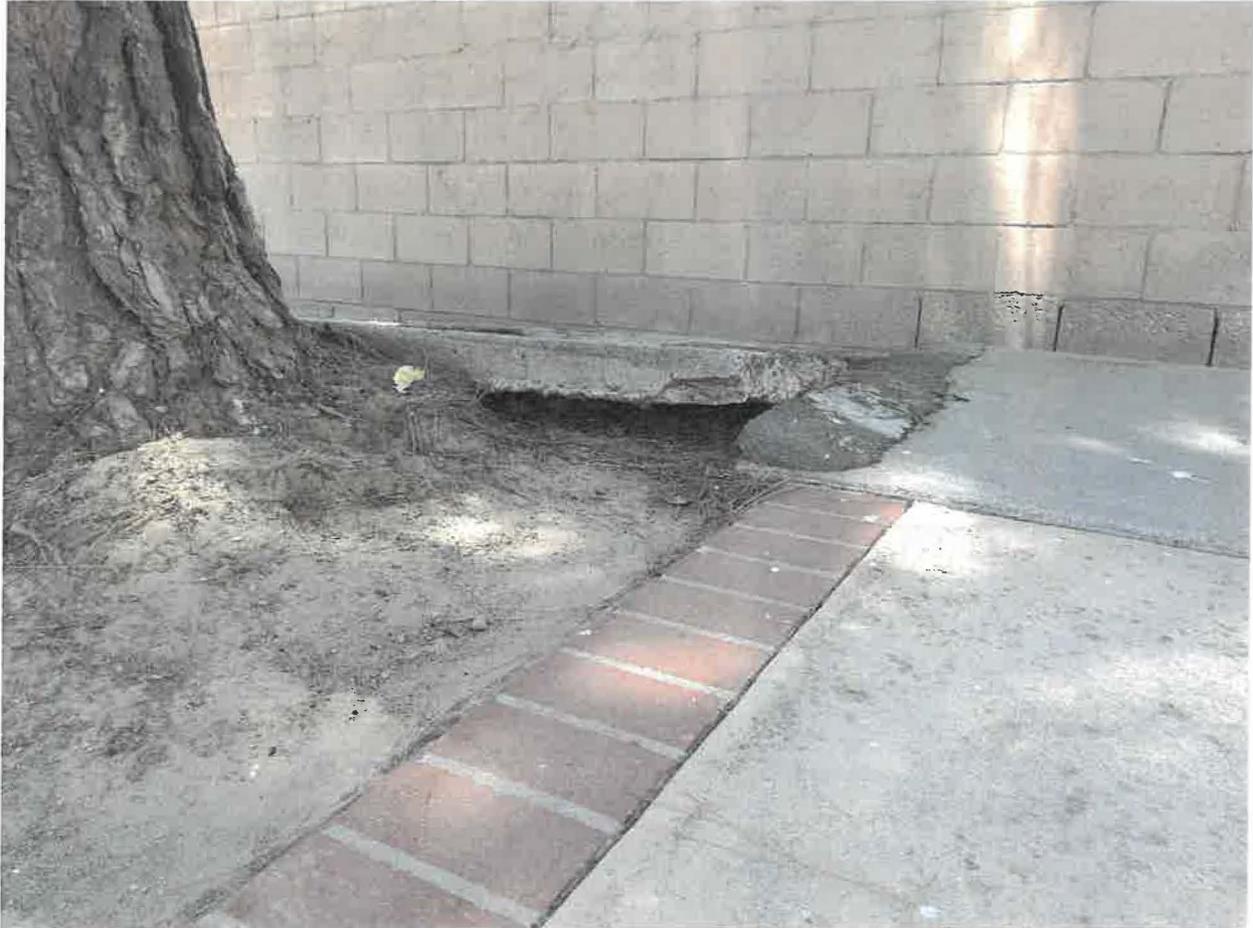
18717 W MAYALL ST (S2)

Proposed to be Removed - UFD cannot ramp over the pine tree roots since the prevailing grade of the street exceeds 5%. The Canary Island pine has an elevated root flare creating severe off grade sidewalk conditions. Large diameter roots are extending under the existing sidewalk. Excessive/ imprudent amount of roots would require pruning to achieve ADA grade requirements & Certificate Of Compliance. Ramping over roots and sidewalk width reduction have been considered as an effort toward tree-preservation yet would not be sufficient due to the extent of repairs surrounding this parkway tree. Root pruning of critical roots will render the trees unstable. Removal is recommended as the best course of action. This genus of trees and its inherent intolerance to root-pruning is the primary factor in UFDs recommendation that no anchoring roots shall be severed at time of Demolition/construction.

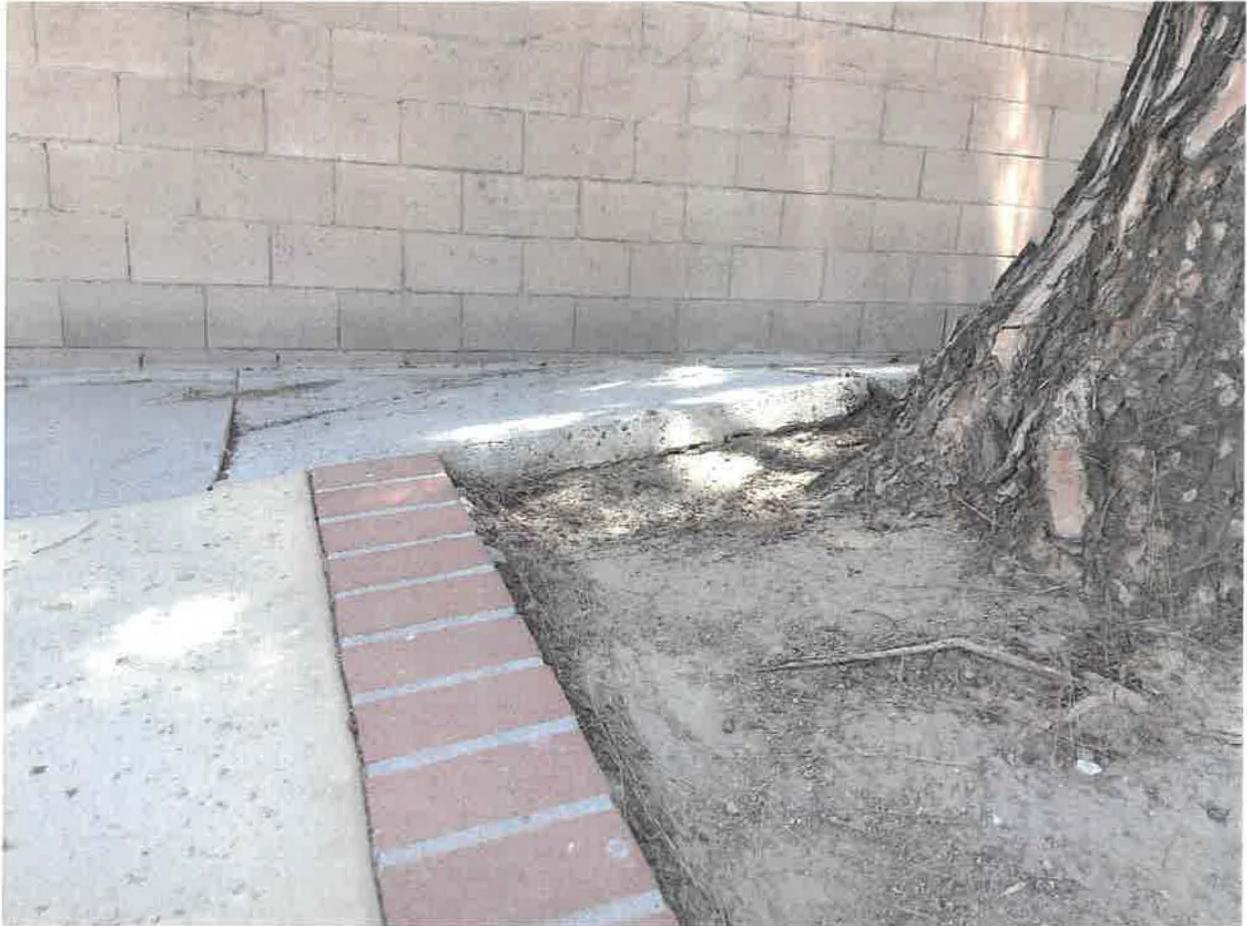
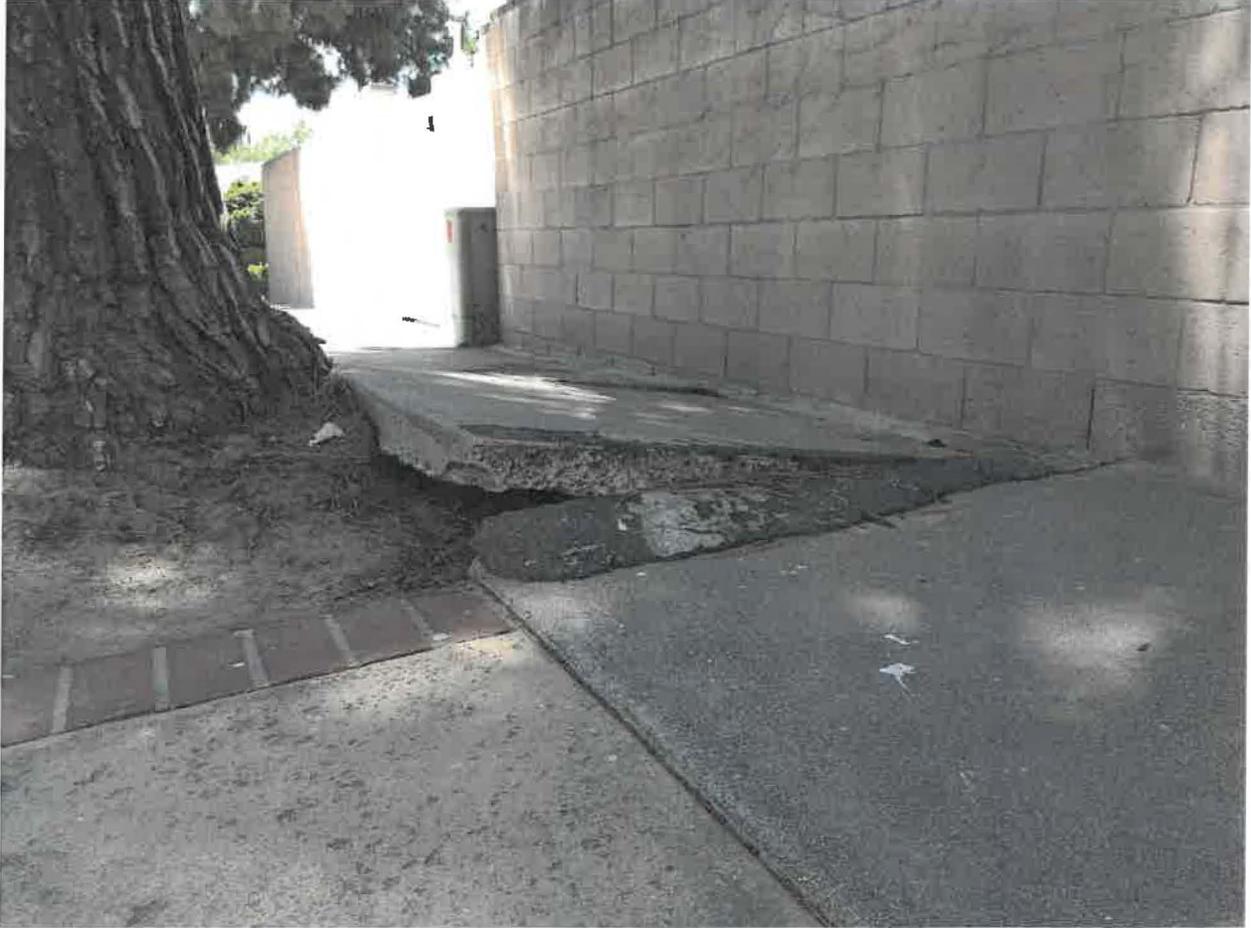
18717 W MAYALL ST (S2)

Proposed to be Removed - UFD cannot ramp over the pine tree roots since the prevailing grade of the street exceeds 5%. The Canary Island pine has an elevated root flare creating severe off grade sidewalk conditions. Large diameter roots are extending under the existing sidewalk. Excessive/ imprudent amount of roots would require pruning to achieve ADA grade requirements & Certificate Of Compliance. Ramping over roots and sidewalk width reduction have been considered as an effort toward tree-preservation yet would not be sufficient due to the extent of repairs surrounding this parkway tree. Root pruning of critical roots will render the trees unstable. Removal is recommended as the best course of action. This genus of trees and its inherent intolerance to root-pruning is the primary factor in UFDs recommendation that no anchoring roots shall be severed at time of Demolition/construction.

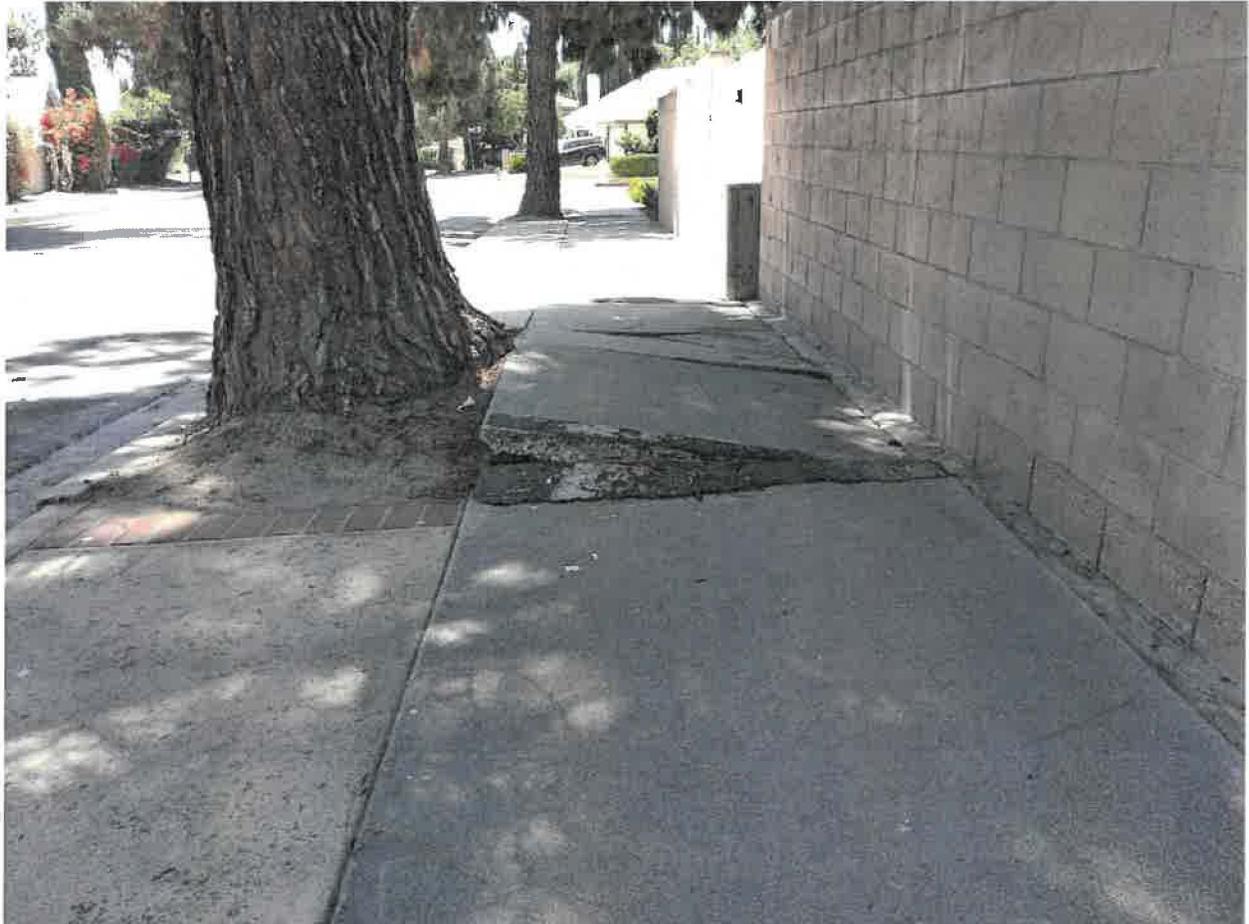
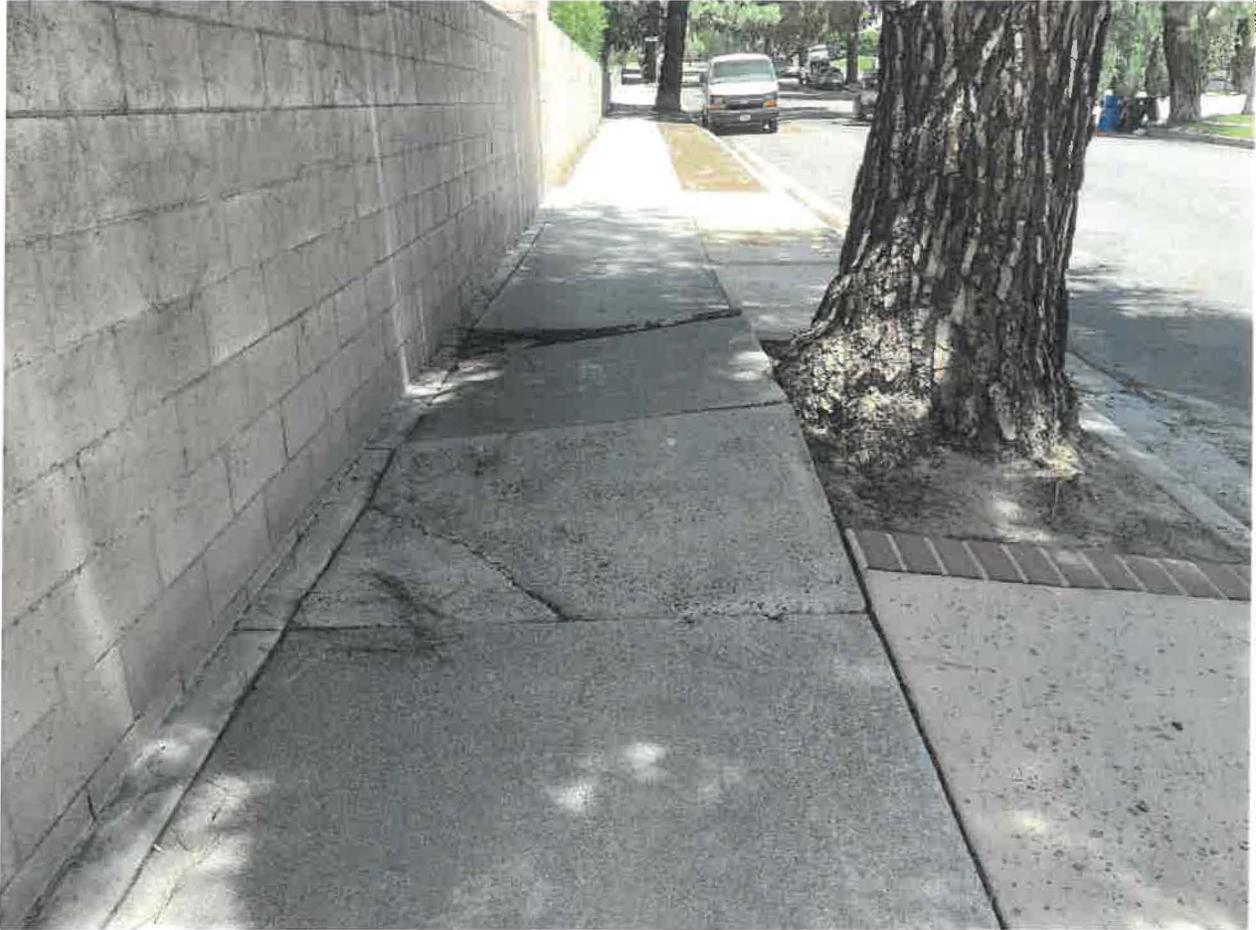
18717 W MAYALL ST (S2)

Proposed to be Removed - UFD cannot ramp over the pine tree roots since the prevailing grade of the street exceeds 5%. The Canary Island pine has an elevated root flare creating severe off grade sidewalk conditions. Large diameter roots are extending under the existing sidewalk. Excessive/ imprudent amount of roots would require pruning to achieve ADA grade requirements & Certificate Of Compliance. Ramping over roots and sidewalk width reduction have been considered as an effort toward tree-preservation yet would not be sufficient due to the extent of repairs surrounding this parkway tree. Root pruning of critical roots will render the trees unstable. Removal is recommended as the best course of action. This genus of trees and its inherent intolerance to root-pruning is the primary factor in UFDs recommendation that no anchoring roots shall be severed at time of Demolition/construction.

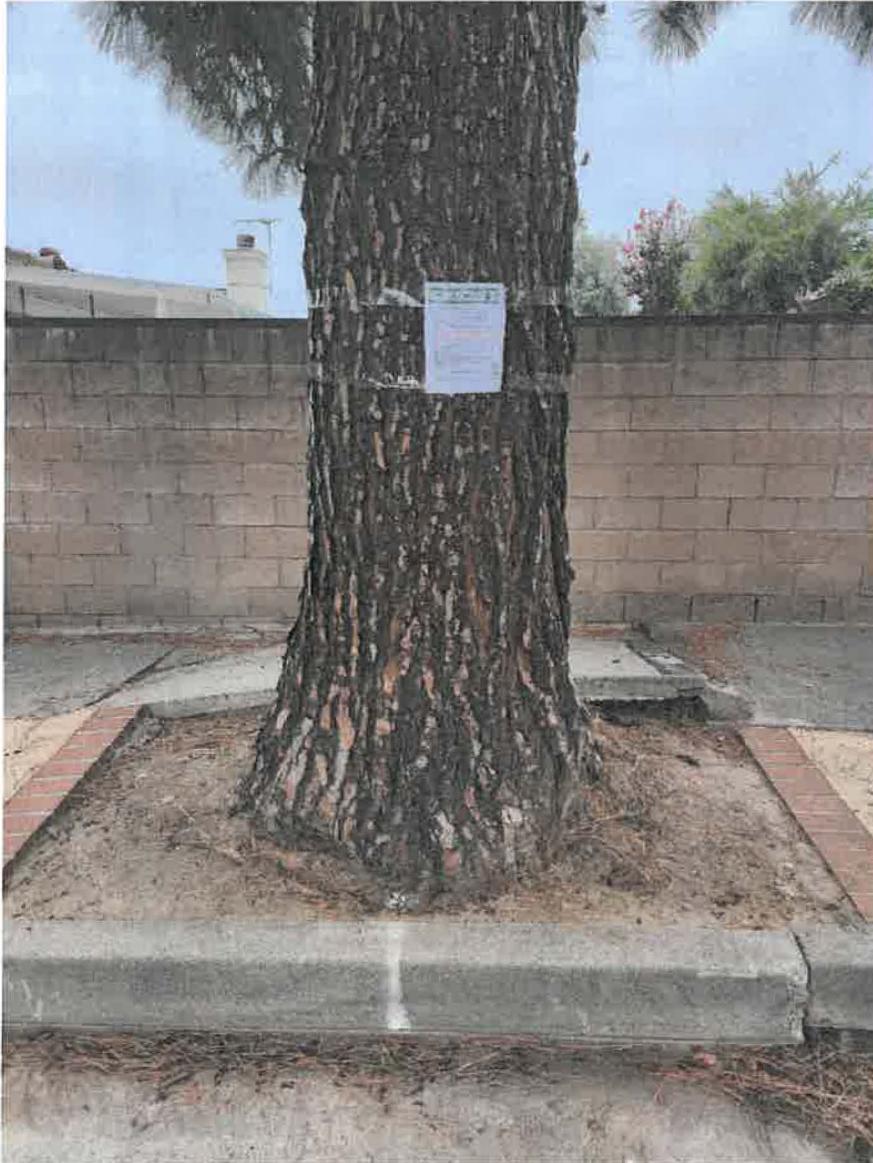
18717 W MAYALL ST (S2)

Proposed to be Removed - UFD cannot ramp over the pine tree roots since the prevailing grade of the street exceeds 5%. The Canary Island pine has an elevated root flare creating severe off grade sidewalk conditions. Large diameter roots are extending under the existing sidewalk. Excessive/ imprudent amount of roots would require pruning to achieve ADA grade requirements & Certificate Of Compliance. Ramping over roots and sidewalk width reduction have been considered as an effort toward tree-preservation yet would not be sufficient due to the extent of repairs surrounding this parkway tree. Root pruning of critical roots will render the trees unstable. Removal is recommended as the best course of action. This genus of trees and its inherent intolerance to root-pruning is the primary factor in UFDs recommendation that no anchoring roots shall be severed at time of Demolition/construction.

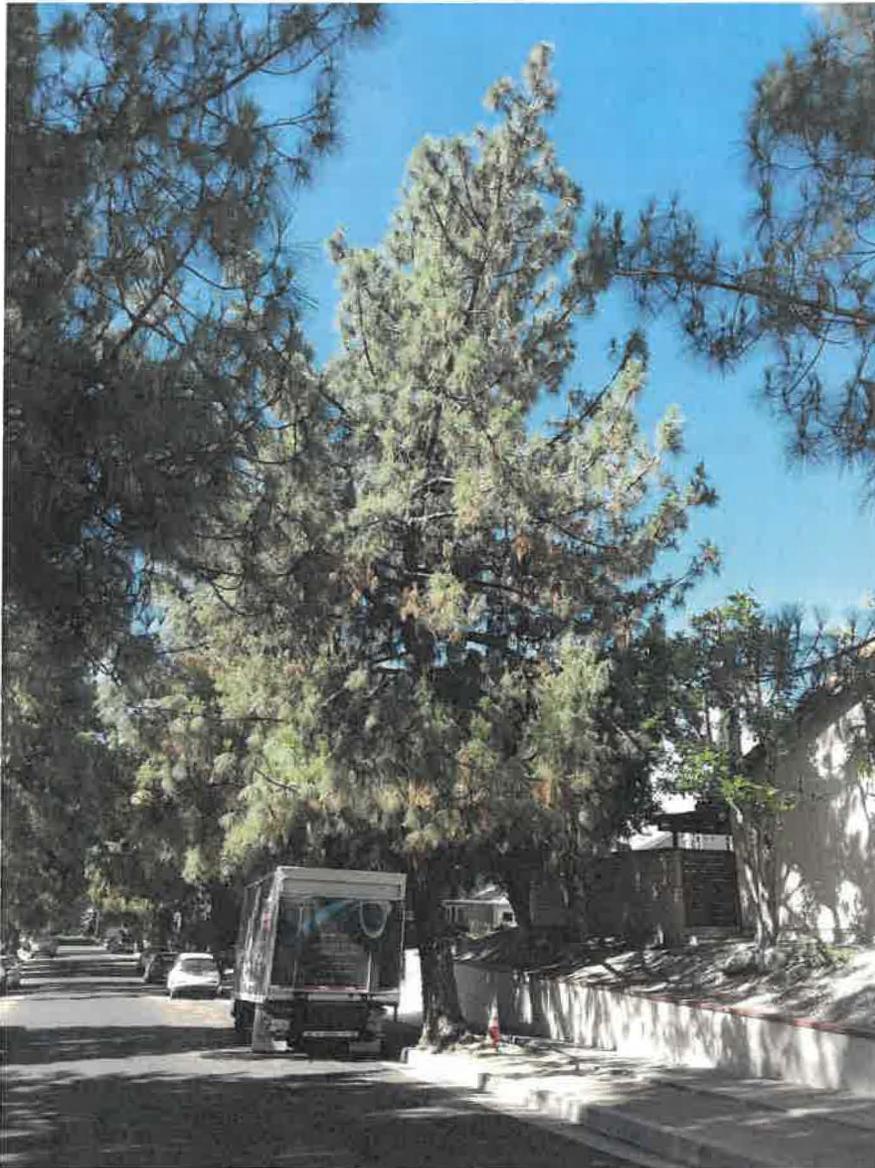
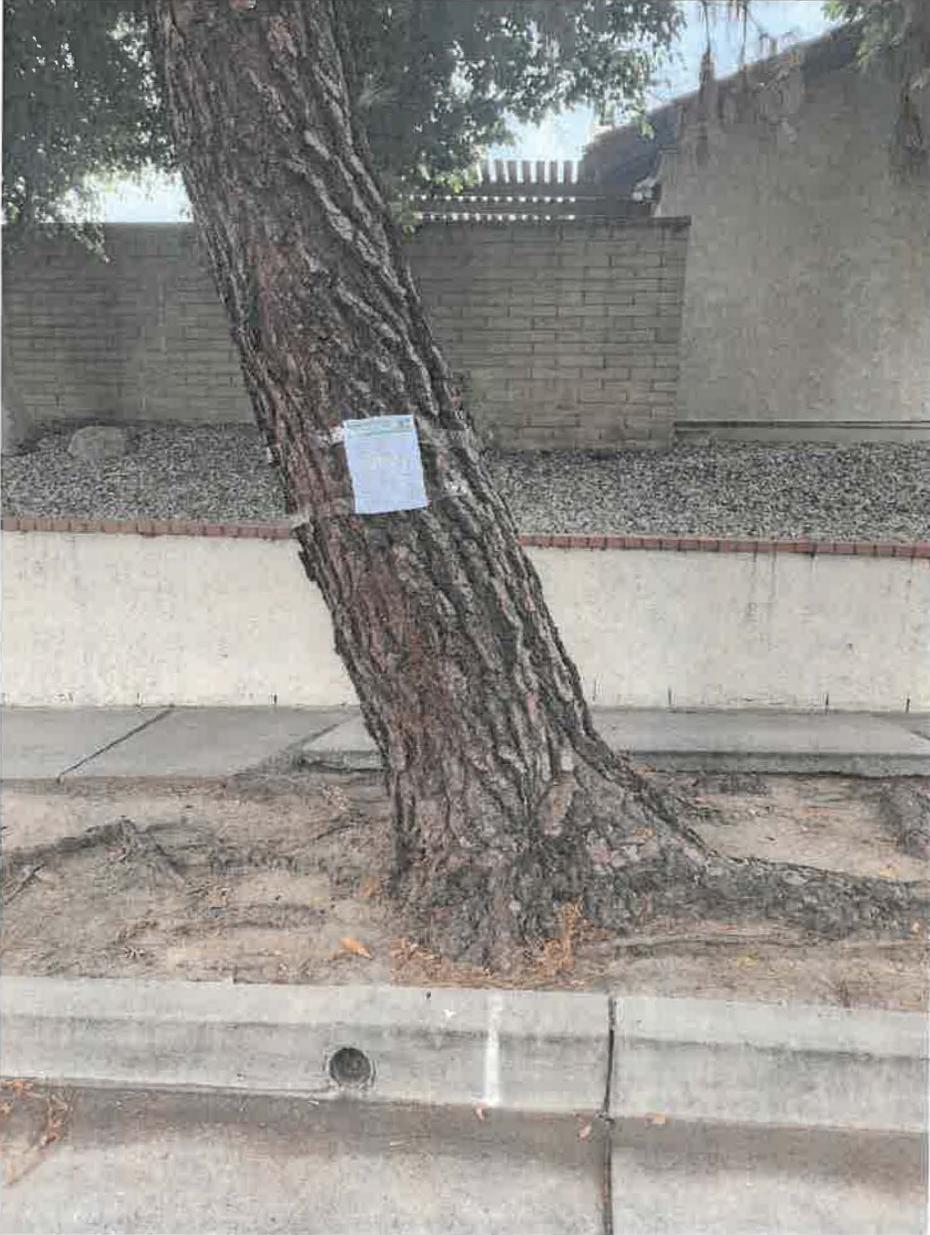
10155 GLADBECK AVE (F1)

Proposed to be Removed - UFD cannot ramp over the pine tree roots since the prevailing grade of the street exceeds 5%. The Canary Island pine has an elevated root flare creating severe off grade sidewalk conditions. Large diameter roots are extending under the existing sidewalk. Excessive/ imprudent amount of roots would require pruning to achieve ADA grade requirements & Certificate Of Compliance. Ramping over roots and sidewalk width reduction have been considered as an effort toward tree-preservation yet would not be sufficient due to the extent of repairs surrounding this parkway tree. Root pruning of critical roots will render the trees unstable. Removal is recommended as the best course of action. This genus of trees and its inherent intolerance to root-pruning is the primary factor in UFDs recommendation that no anchoring roots shall be severed at time of Demolition/construction.

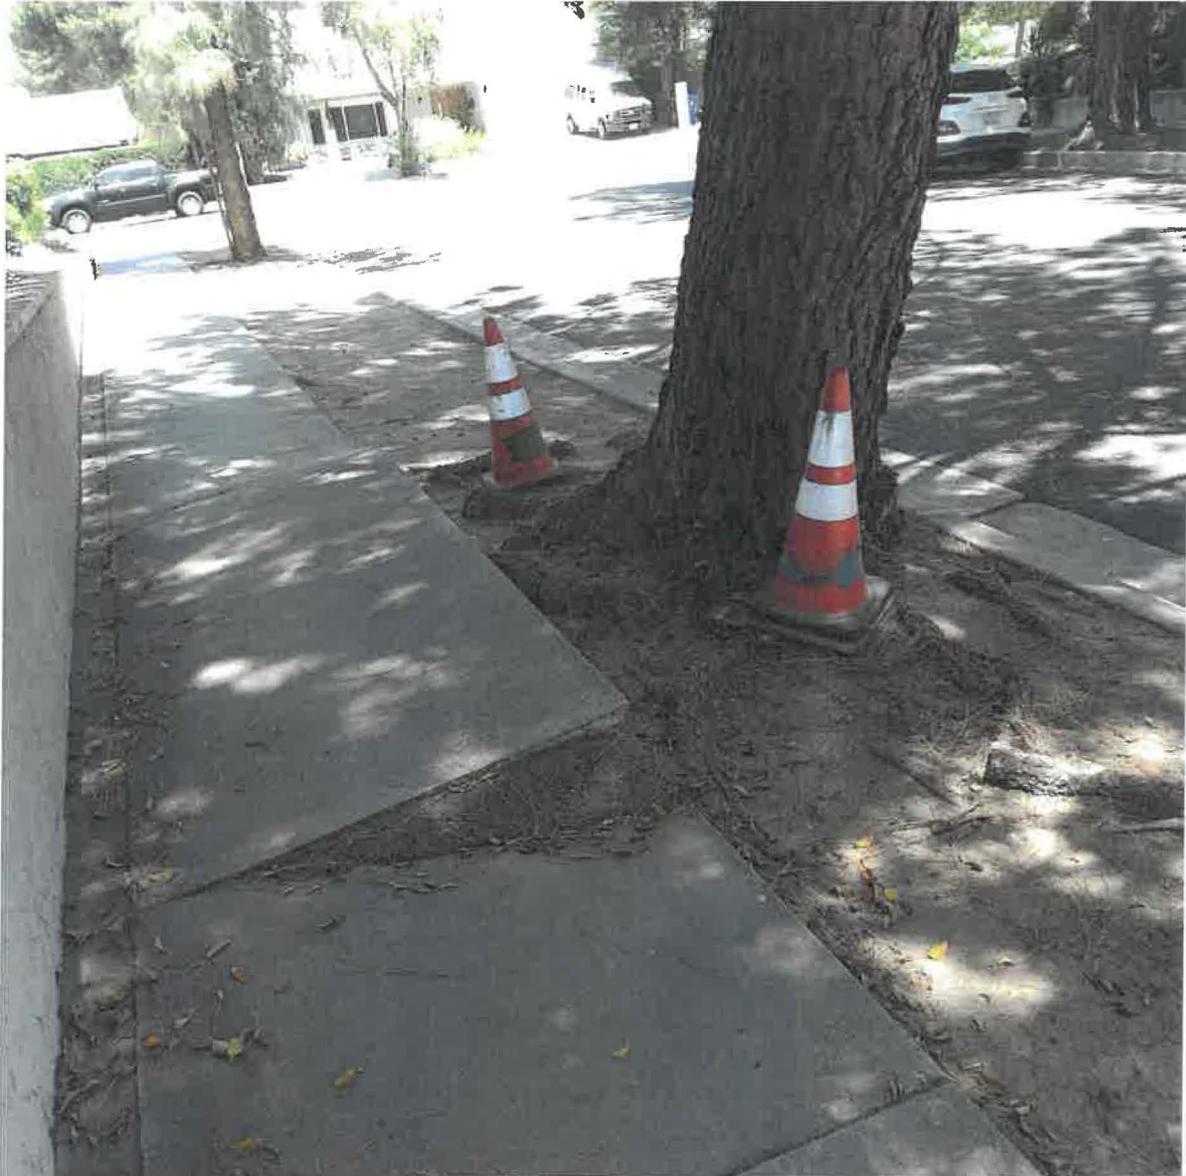
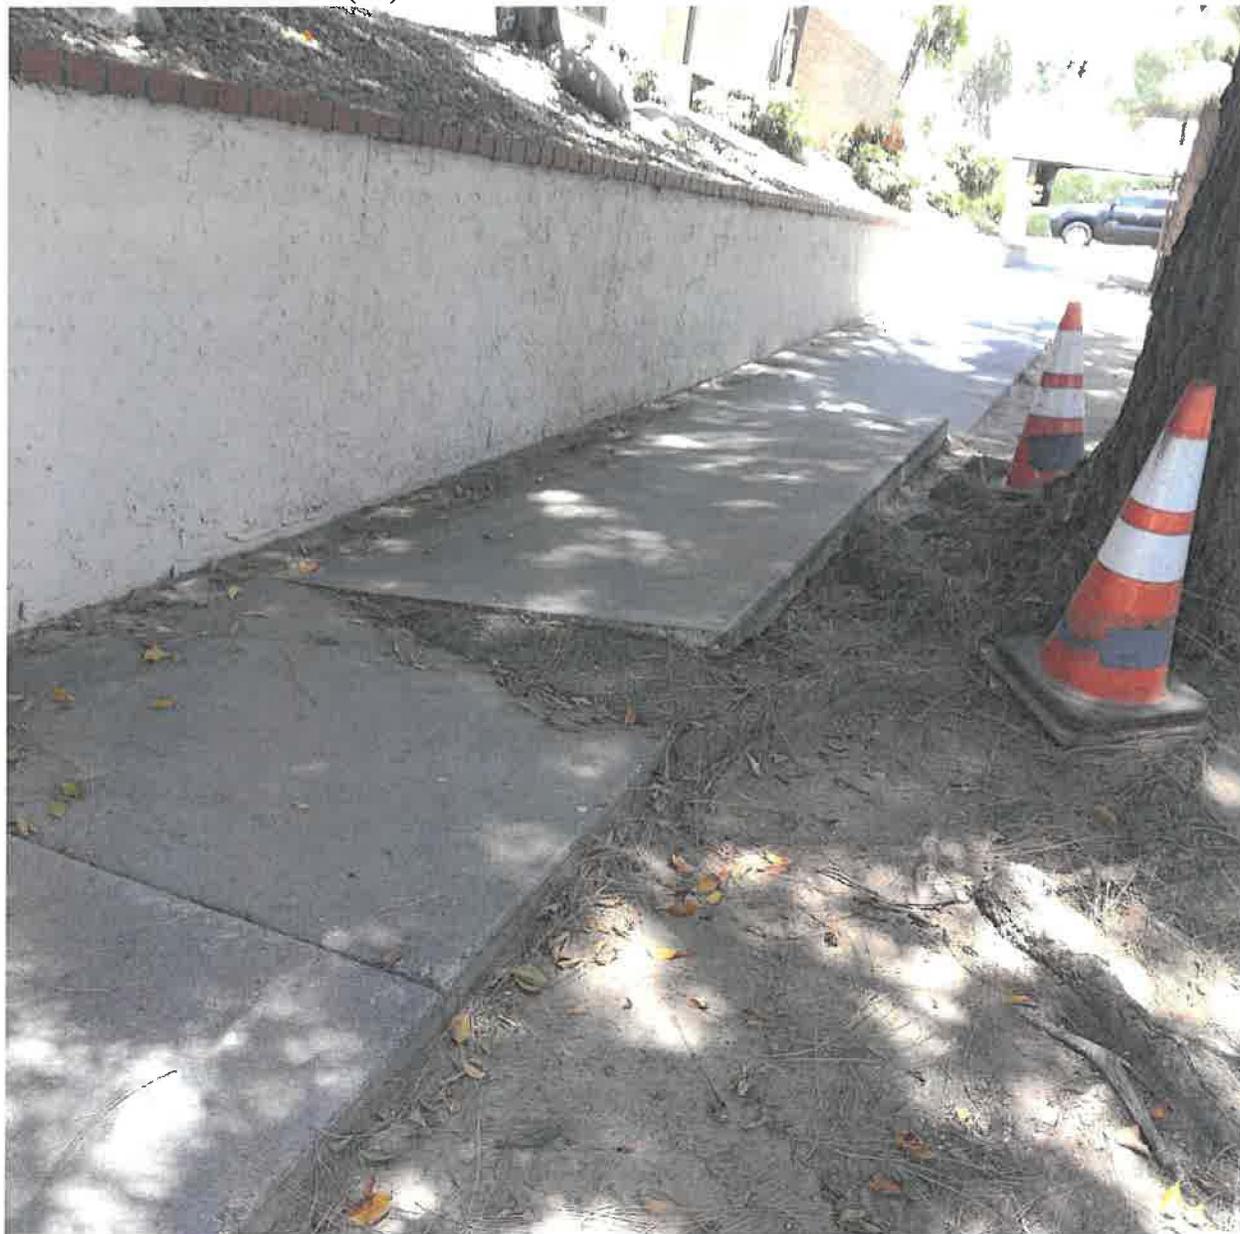
10155 GLADBECK AVE (F1)

Proposed to be Removed - UFD cannot ramp over the pine tree roots since the prevailing grade of the street exceeds 5%. The Canary Island pine has an elevated root flare creating severe off grade sidewalk conditions. Large diameter roots are extending under the existing sidewalk. Excessive/ imprudent amount of roots would require pruning to achieve ADA grade requirements & Certificate Of Compliance. Ramping over roots and sidewalk width reduction have been considered as an effort toward tree-preservation yet would not be sufficient due to the extent of repairs surrounding this parkway tree. Root pruning of critical roots will render the trees unstable. Removal is recommended as the best course of action. This genus of trees and its inherent intolerance to root-pruning is the primary factor in UFDs recommendation that no anchoring roots shall be severed at time of Demolition/construction.
