DEPARTMENT OF PUBLIC WORKS
BUREAU OF STREET SERVICES
REPORT NO.1

18700 BLOCK WEST MAYALL AVENUE AND ADJACENT STREETS (BOE – 68) – CITYWIDE SIDEWALK REPAIR PROGRAM IN COUNCIL DISTRICT TWELVE REQUEST BOARD OF PUBLIC WORKS TO CONCUR WITH A SIDEWALK REPAIR PROJECT AND APPROVE THE REMOVAL OF SEVEN CANARY ISLAND PINE (PINUS CANARIENSIS) TREES FOR THE RECONSTRUCTION OF THE NON-ADA COMPLIANT PUBLIC SIDEWALK. TREE REPLACEMENTS ARE REQUIRED.

TRANSMITTAL NO. 5

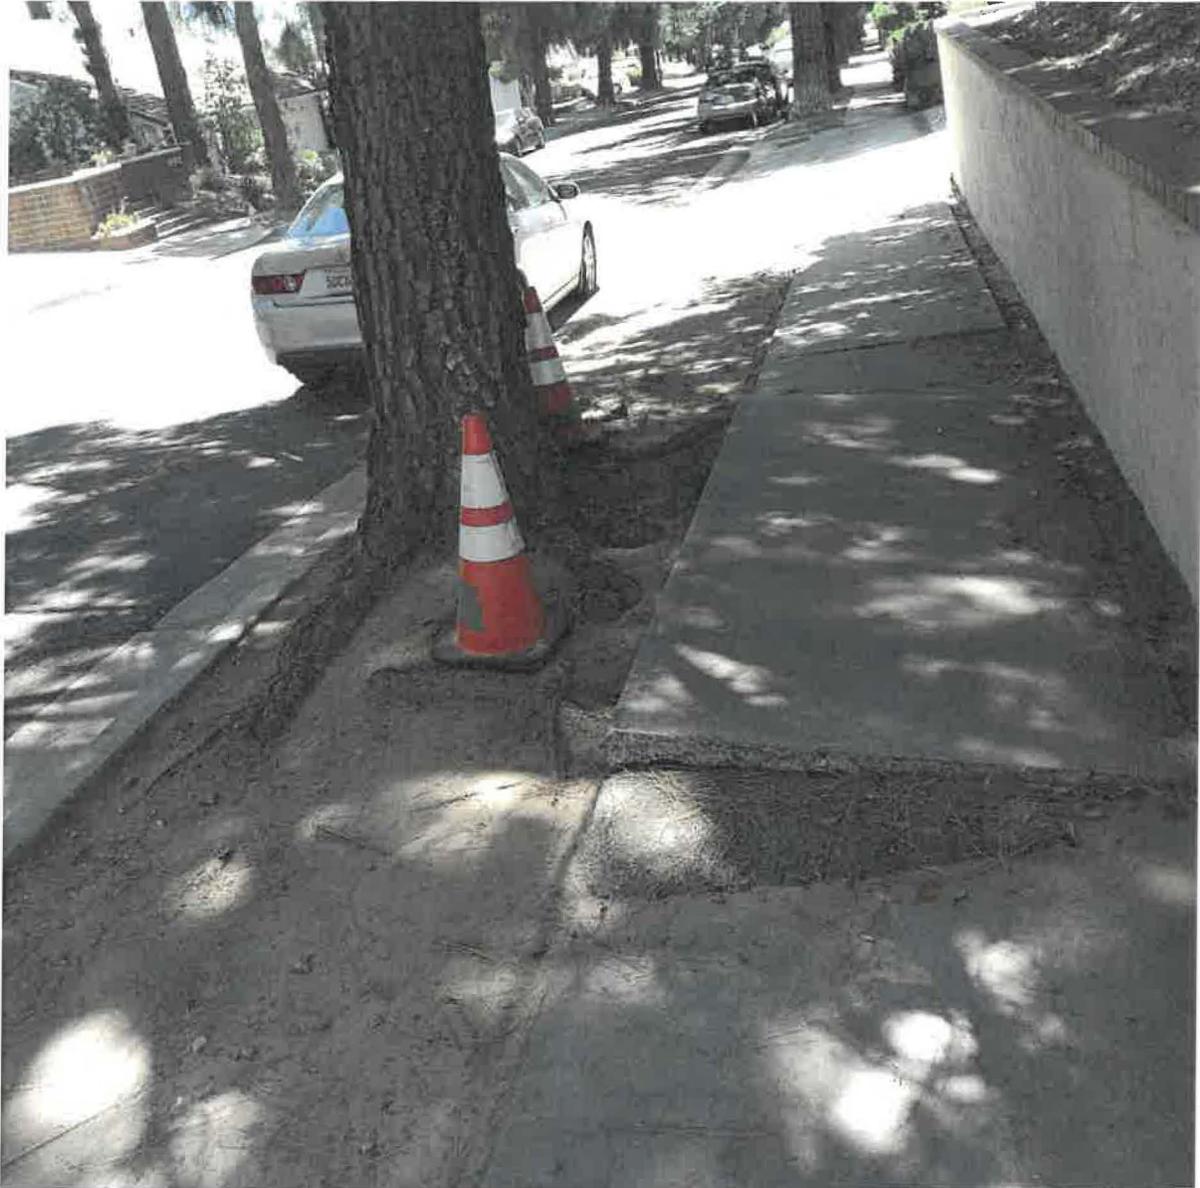
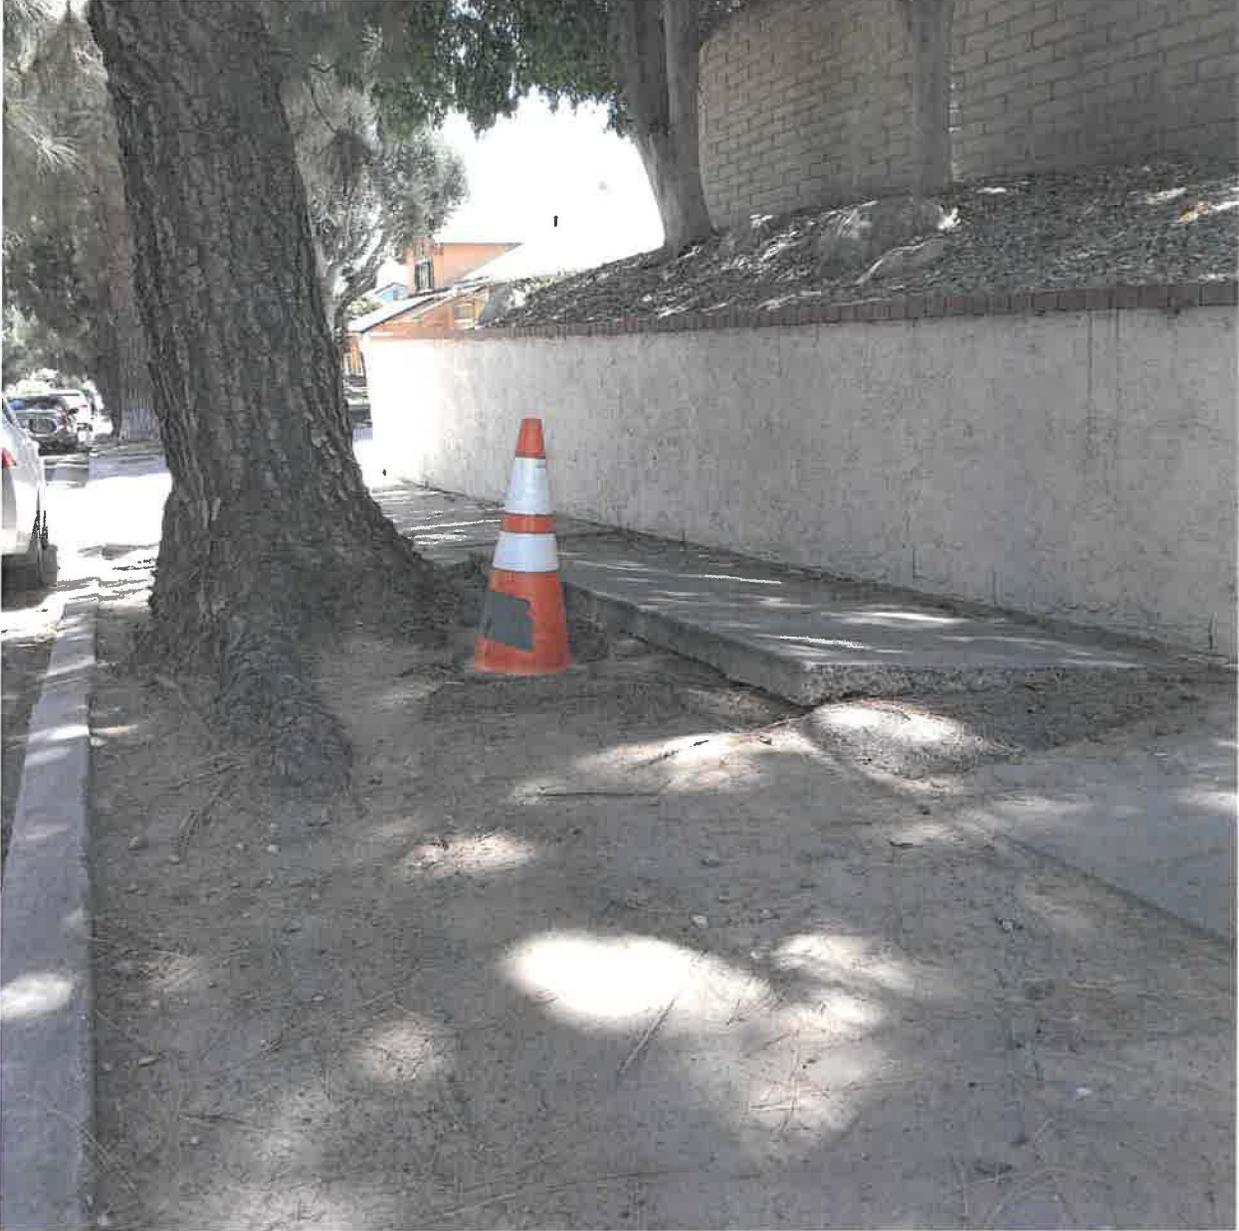
10155 GLADBECK AVE (F1)

Proposed to be Removed - UFD cannot ramp over the pine tree roots since the prevailing grade of the street exceeds 5%. The Canary Island pine has an elevated root flare creating severe off grade sidewalk conditions. Large diameter roots are extending under the existing sidewalk. Excessive/ imprudent amount of roots would require pruning to achieve ADA grade requirements & Certificate Of Compliance. Ramping over roots and sidewalk width reduction have been considered as an effort toward tree-preservation yet would not be sufficient due to the extent of repairs surrounding this parkway tree. Root pruning of critical roots will render the trees unstable. Removal is recommended as the best course of action. This genus of trees and its inherent intolerance to root-pruning is the primary factor in UFDs recommendation that no anchoring roots shall be severed at time of Demolition/construction.

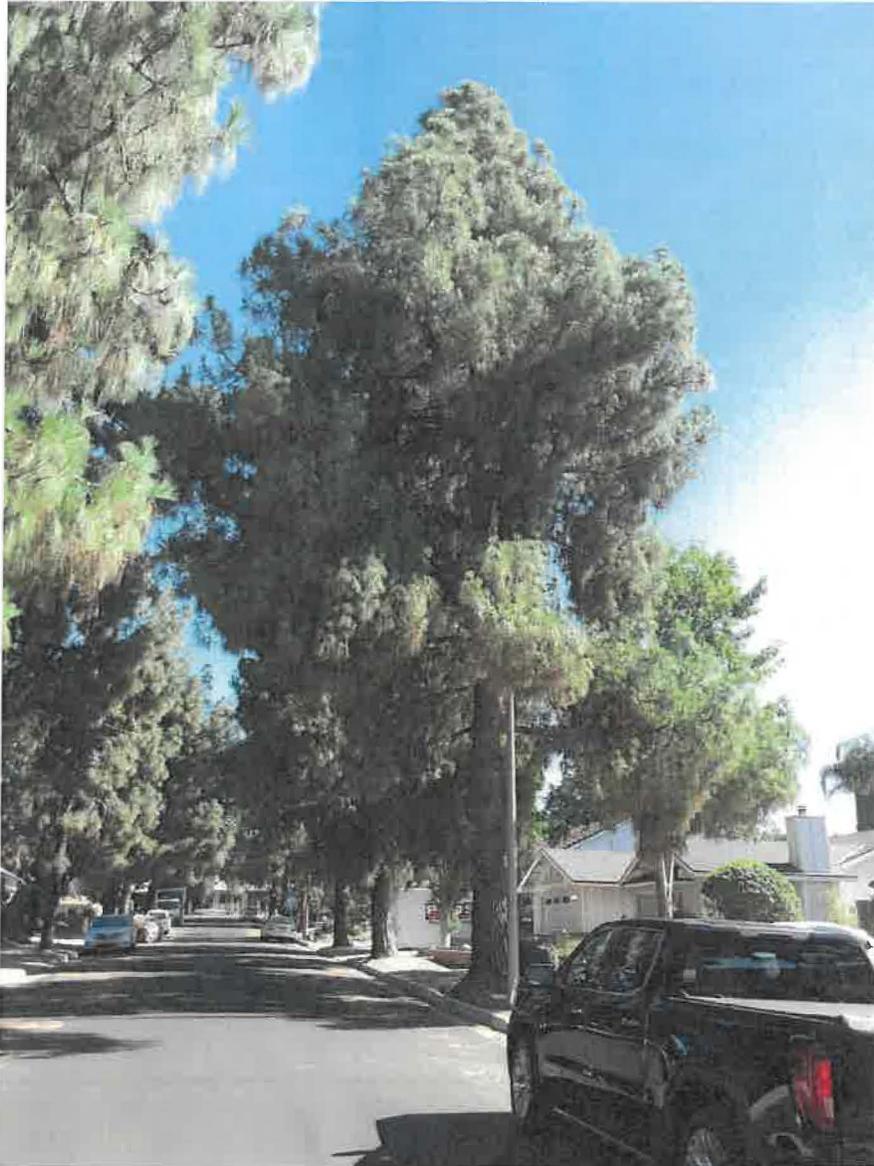
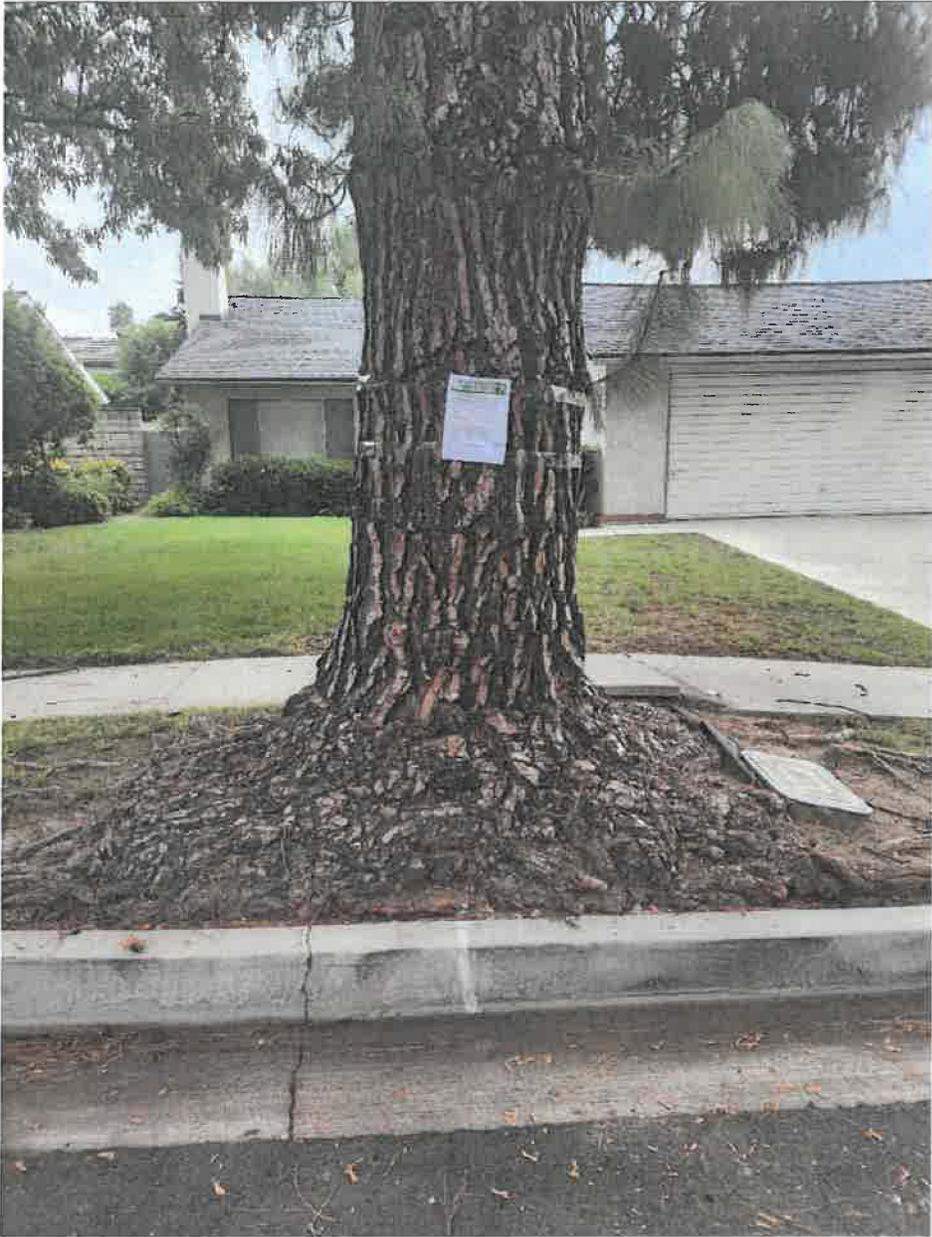
10122 GLADBECK AVE (F1)

Proposed to be Removed - UFD cannot ramp over the pine tree roots since the prevailing grade of the street exceeds 5%. The Canary Island pine has an elevated root flare creating severe off grade sidewalk conditions. Large diameter roots are extending under the existing sidewalk. Excessive/ imprudent amount of roots would require pruning to achieve ADA grade requirements & Certificate Of Compliance. Ramping over roots and sidewalk width reduction have been considered as an effort toward tree-preservation yet would not be sufficient due to the extent of repairs surrounding this parkway tree. Root pruning of critical roots will render the trees unstable. Removal is recommended as the best course of action. This genus of trees and its inherent intolerance to root-pruning is the primary factor in UFDs recommendation that no anchoring roots shall be severed at time of Demolition/construction.

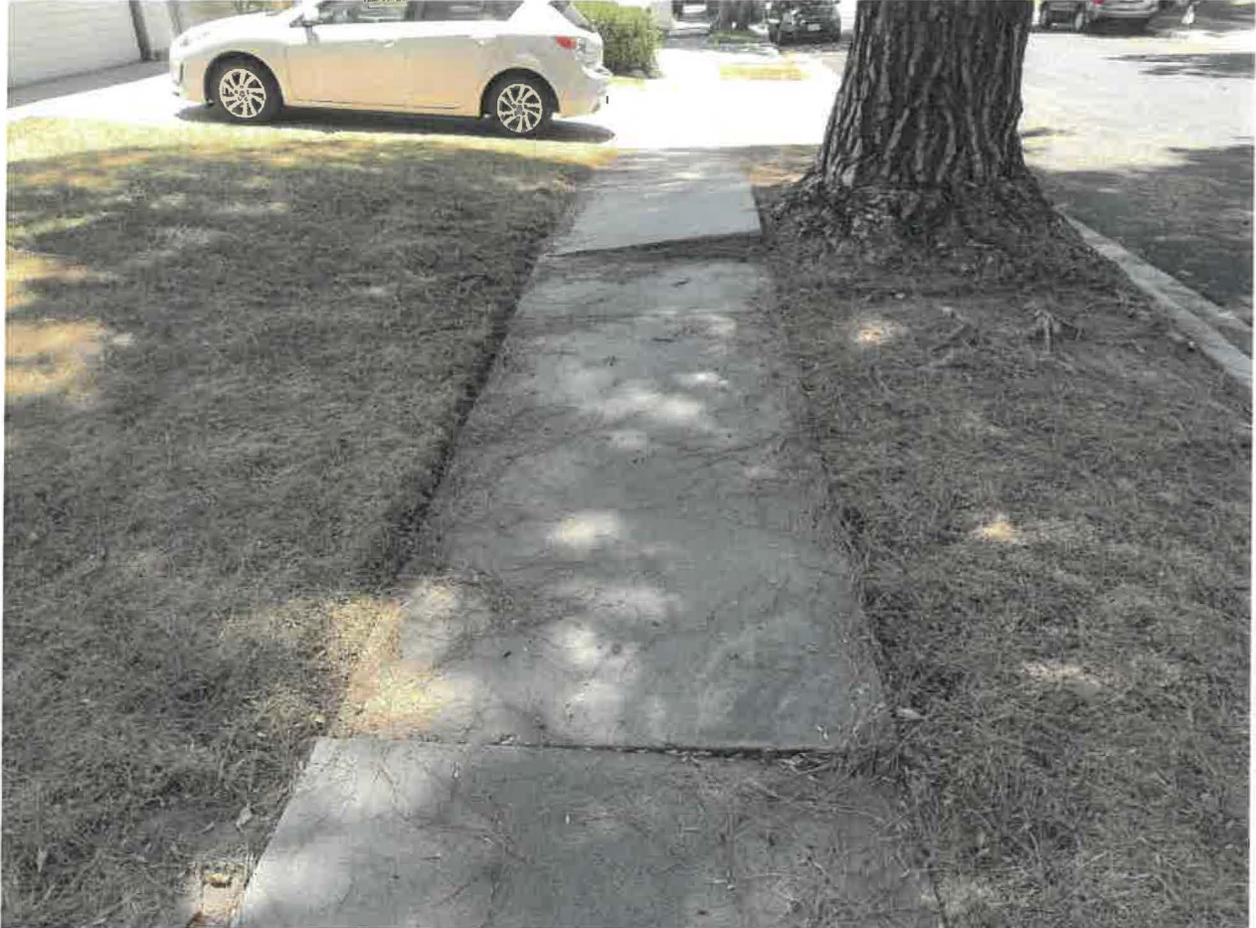
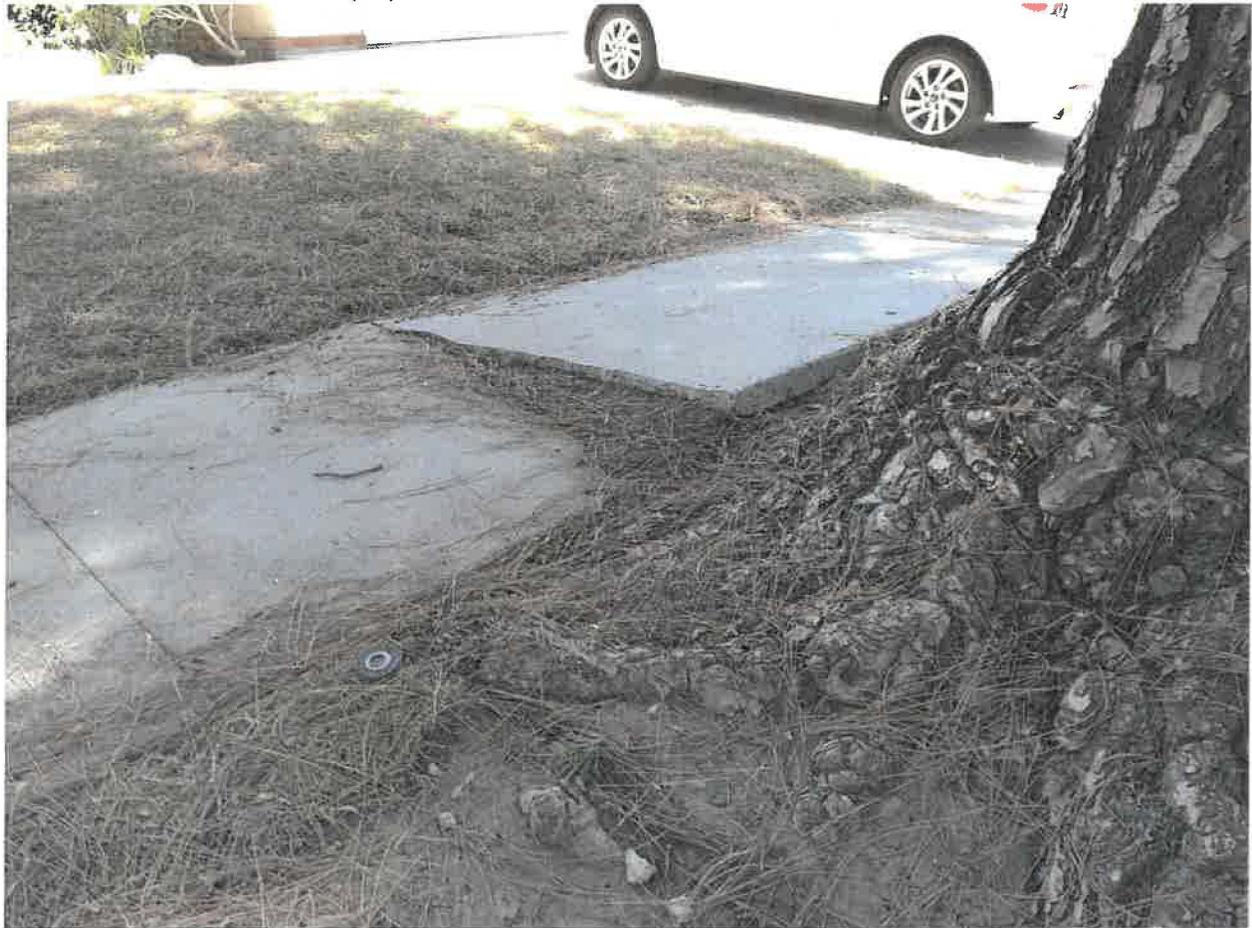
10122 GLADBECK AVE (F1)

Proposed to be Removed - UFD cannot ramp over the pine tree roots since the prevailing grade of the street exceeds 5%. The Canary Island pine has an elevated root flare creating severe off grade sidewalk conditions. Large diameter roots are extending under the existing sidewalk. Excessive/ imprudent amount of roots would require pruning to achieve ADA grade requirements & Certificate Of Compliance. Ramping over roots and sidewalk width reduction have been considered as an effort toward tree-preservation yet would not be sufficient due to the extent of repairs surrounding this parkway tree. Root pruning of critical roots will render the trees unstable. Removal is recommended as the best course of action. This genus of trees and its inherent intolerance to root-pruning is the primary factor in UFDs recommendation that no anchoring roots shall be severed at time of Demolition/construction.

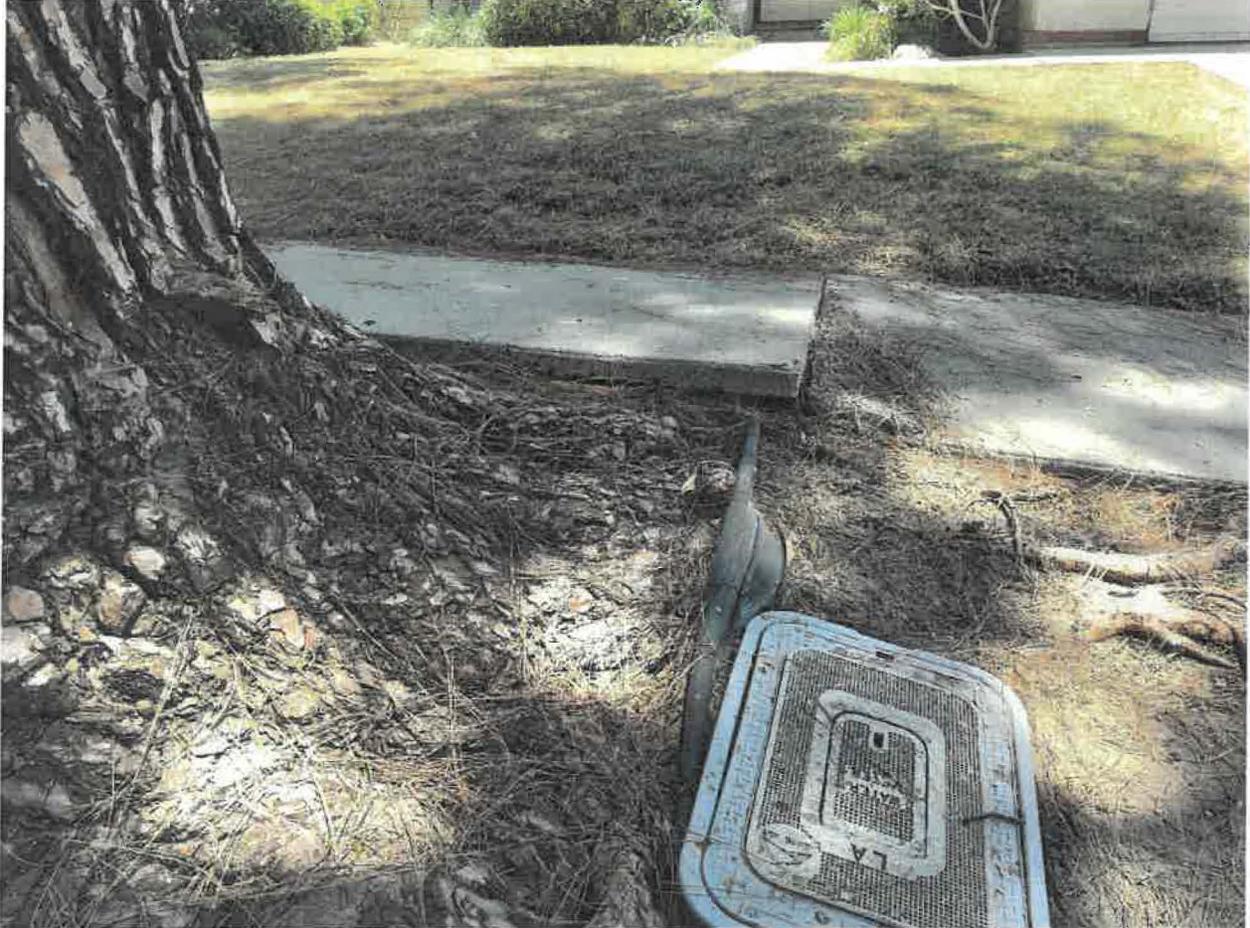
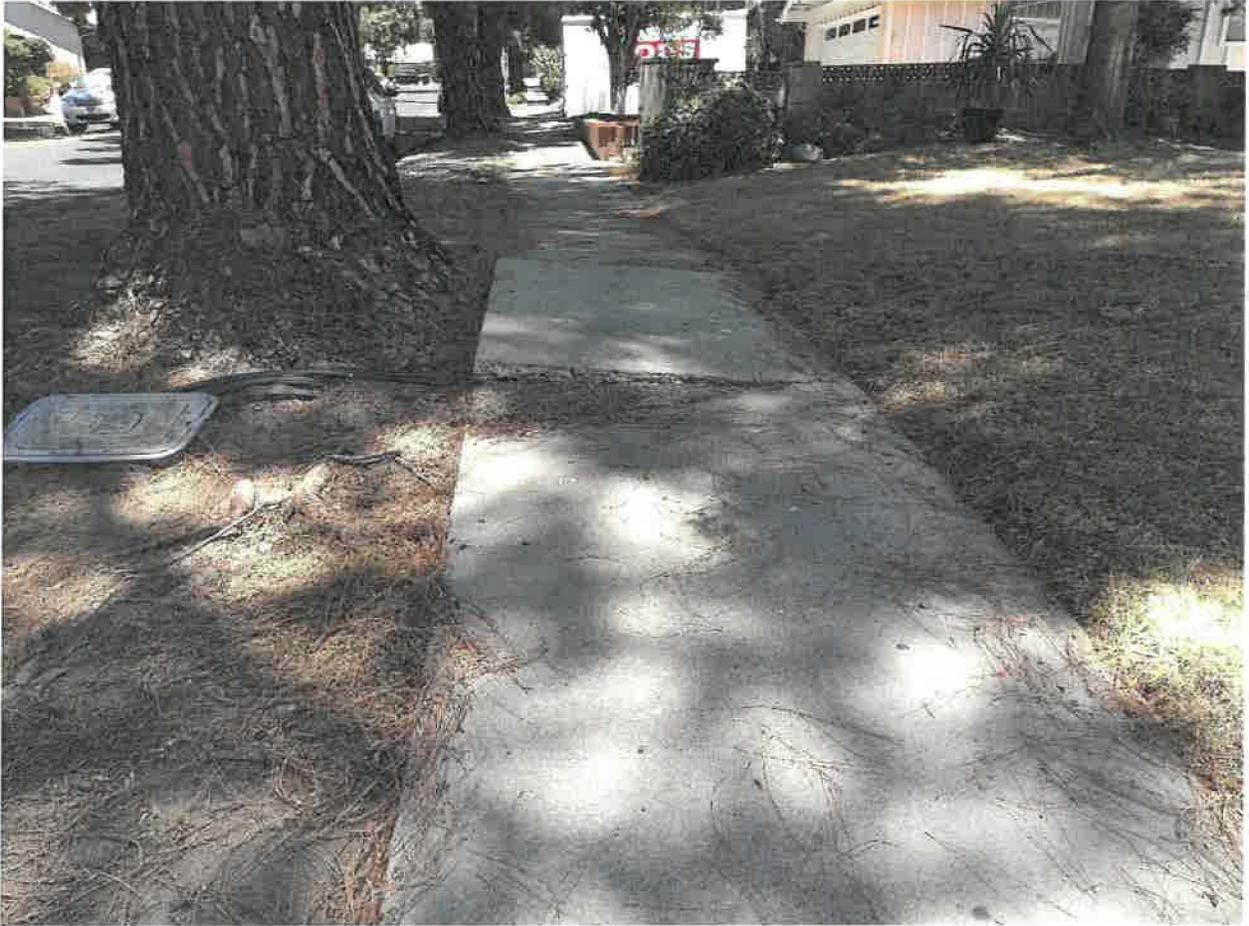
10122 GLADBECK AVE (F1)

Proposed to be Removed - UFD cannot ramp over the pine tree roots since the prevailing grade of the street exceeds 5%. The Canary Island pine has an elevated root flare creating severe off grade sidewalk conditions. Large diameter roots are extending under the existing sidewalk. Excessive/ imprudent amount of roots would require pruning to achieve ADA grade requirements & Certificate Of Compliance. Ramping over roots and sidewalk width reduction have been considered as an effort toward tree-preservation yet would not be sufficient due to the extent of repairs surrounding this parkway tree. Root pruning of critical roots will render the trees unstable. Removal is recommended as the best course of action. This genus of trees and its inherent intolerance to root-pruning is the primary factor in UFDs recommendation that no anchoring roots shall be severed at time of Demolition/construction.

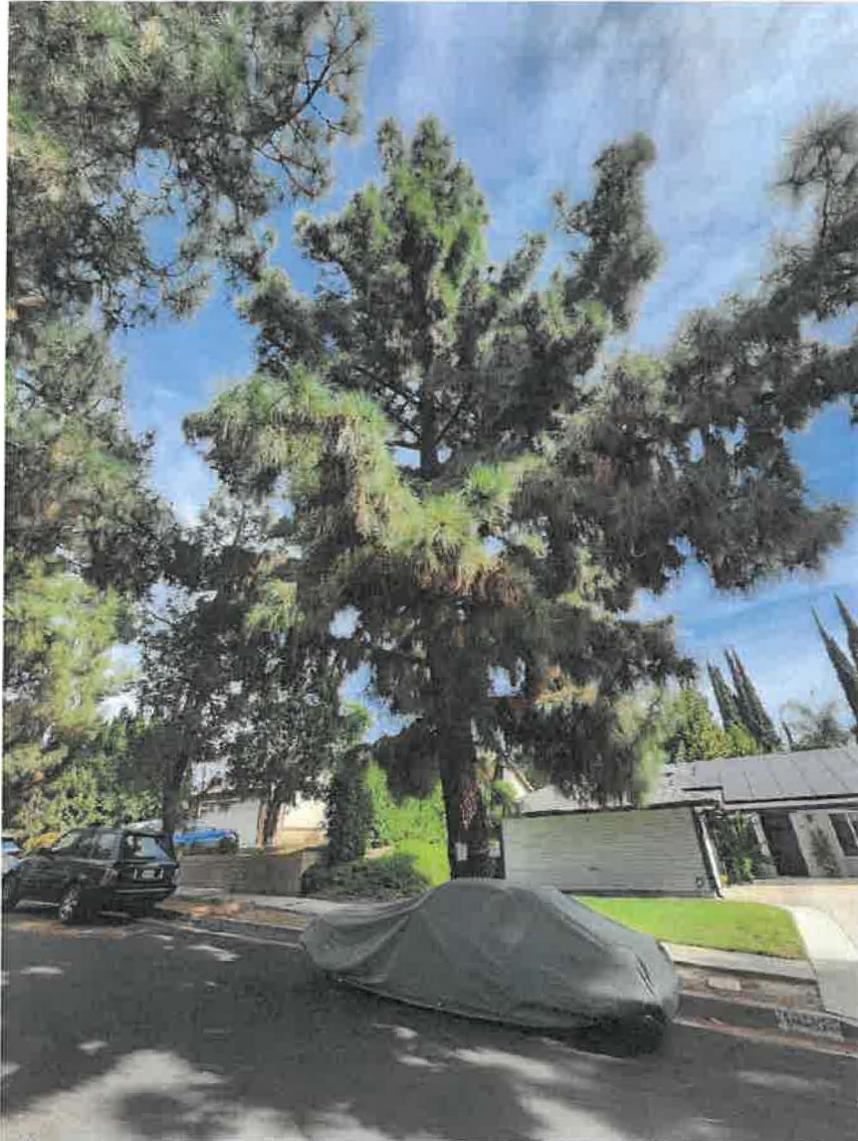
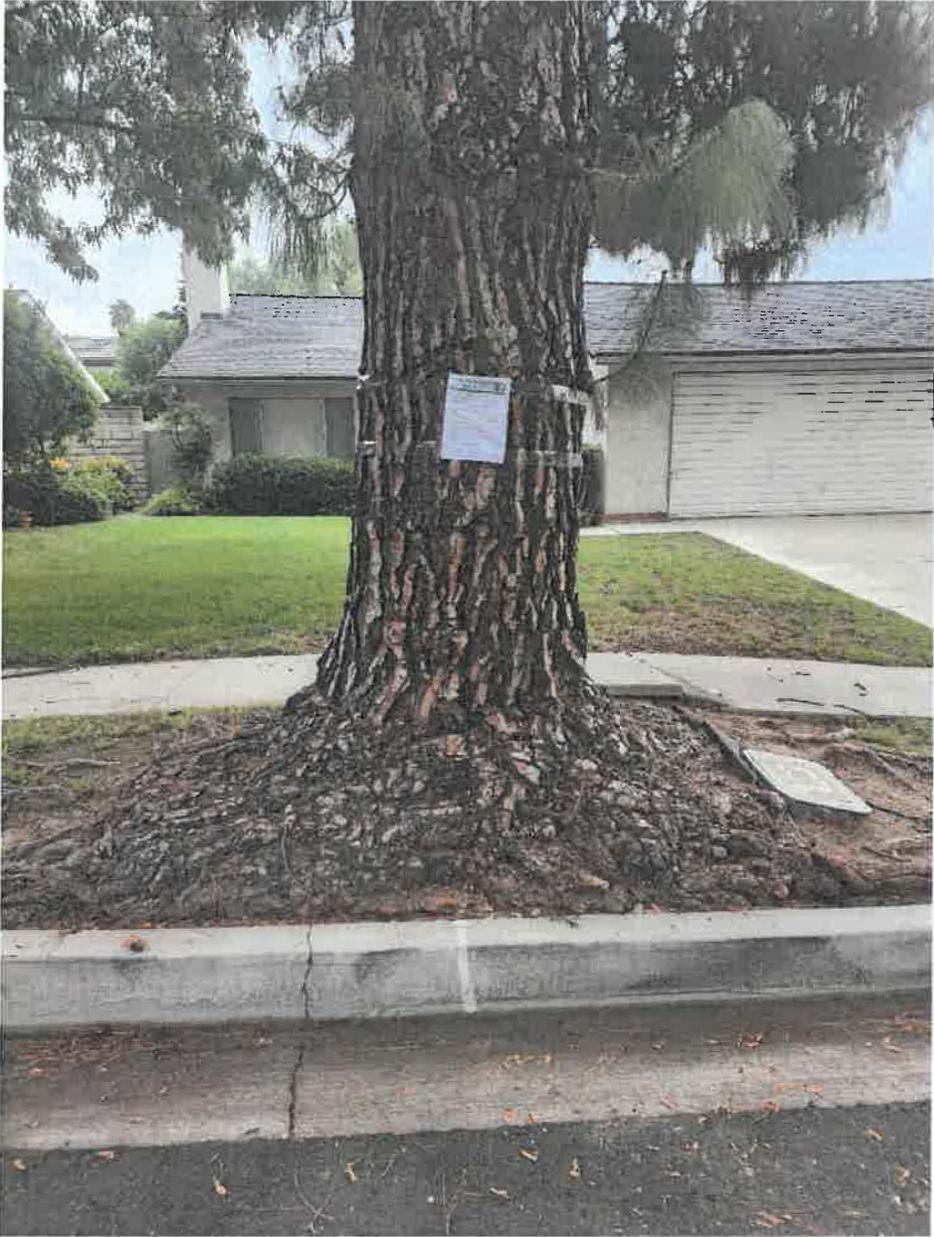
10132 YOLANDA AVE (F1)

Proposed to be Removed - UFD cannot ramp over the pine tree roots since the prevailing grade of the street exceeds 5%. The Canary Island pine has an elevated root flare creating severe off grade sidewalk conditions. Large diameter roots are extending under the existing sidewalk. Excessive/ imprudent amount of roots would require pruning to achieve ADA grade requirements & Certificate Of Compliance. Ramping over roots and sidewalk width reduction have been considered as an effort toward tree-preservation yet would not be sufficient due to the extent of repairs surrounding this parkway tree. Root pruning of critical roots will render the trees unstable. Removal is recommended as the best course of action. This genus of trees and its inherent intolerance to root-pruning is the primary factor in UFDs recommendation that no anchoring roots shall be severed at time of Demolition/construction.

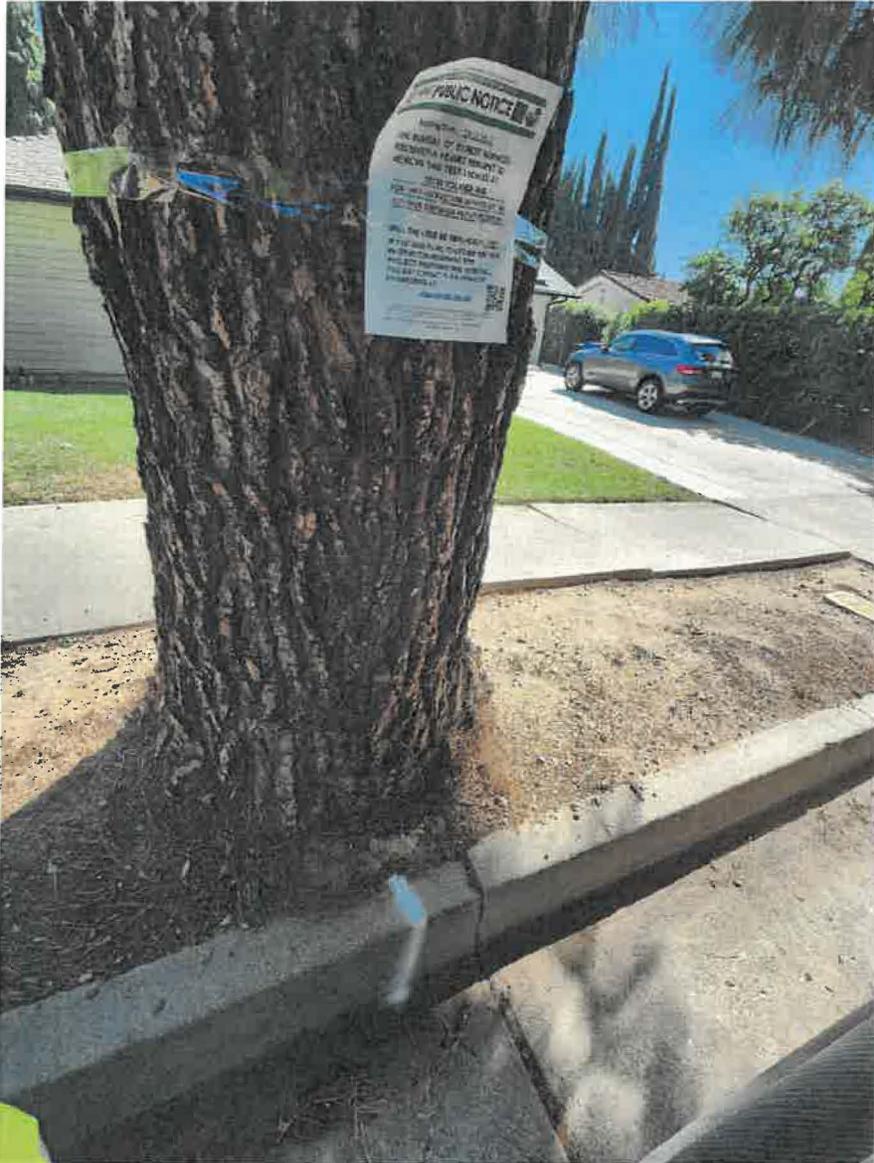
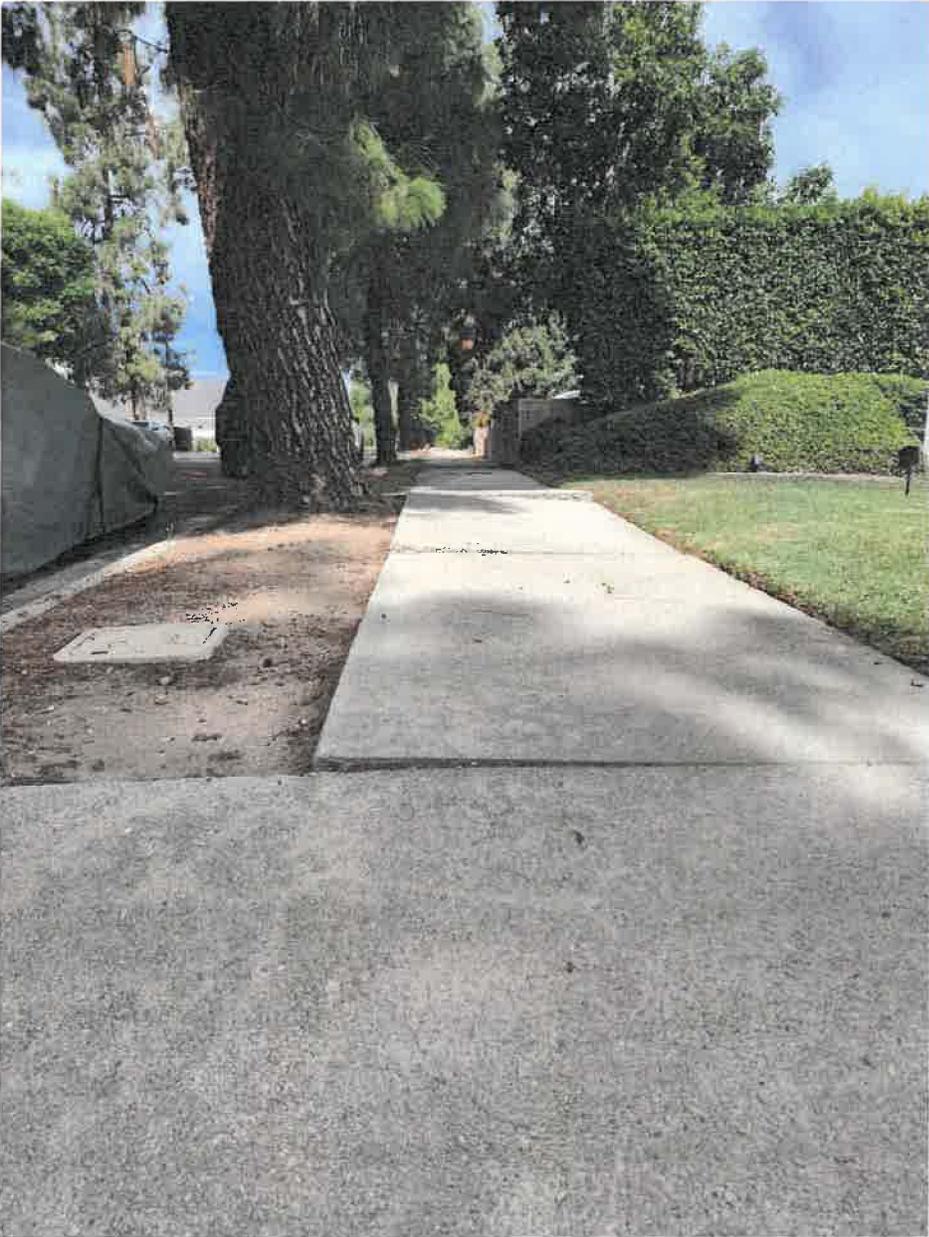
10132 YOLANDA AVE (F1)

Proposed to be Removed - UFD cannot ramp over the pine tree roots since the prevailing grade of the street exceeds 5%. The Canary Island pine has an elevated root flare creating severe off grade sidewalk conditions. Large diameter roots are extending under the existing sidewalk. Excessive/ imprudent amount of roots would require pruning to achieve ADA grade requirements & Certificate Of Compliance. Ramping over roots and sidewalk width reduction have been considered as an effort toward tree-preservation yet would not be sufficient due to the extent of repairs surrounding this parkway tree. Root pruning of critical roots will render the trees unstable. Removal is recommended as the best course of action. This genus of trees and its inherent intolerance to root-pruning is the primary factor in UFDs recommendation that no anchoring roots shall be severed at time of Demolition/construction.

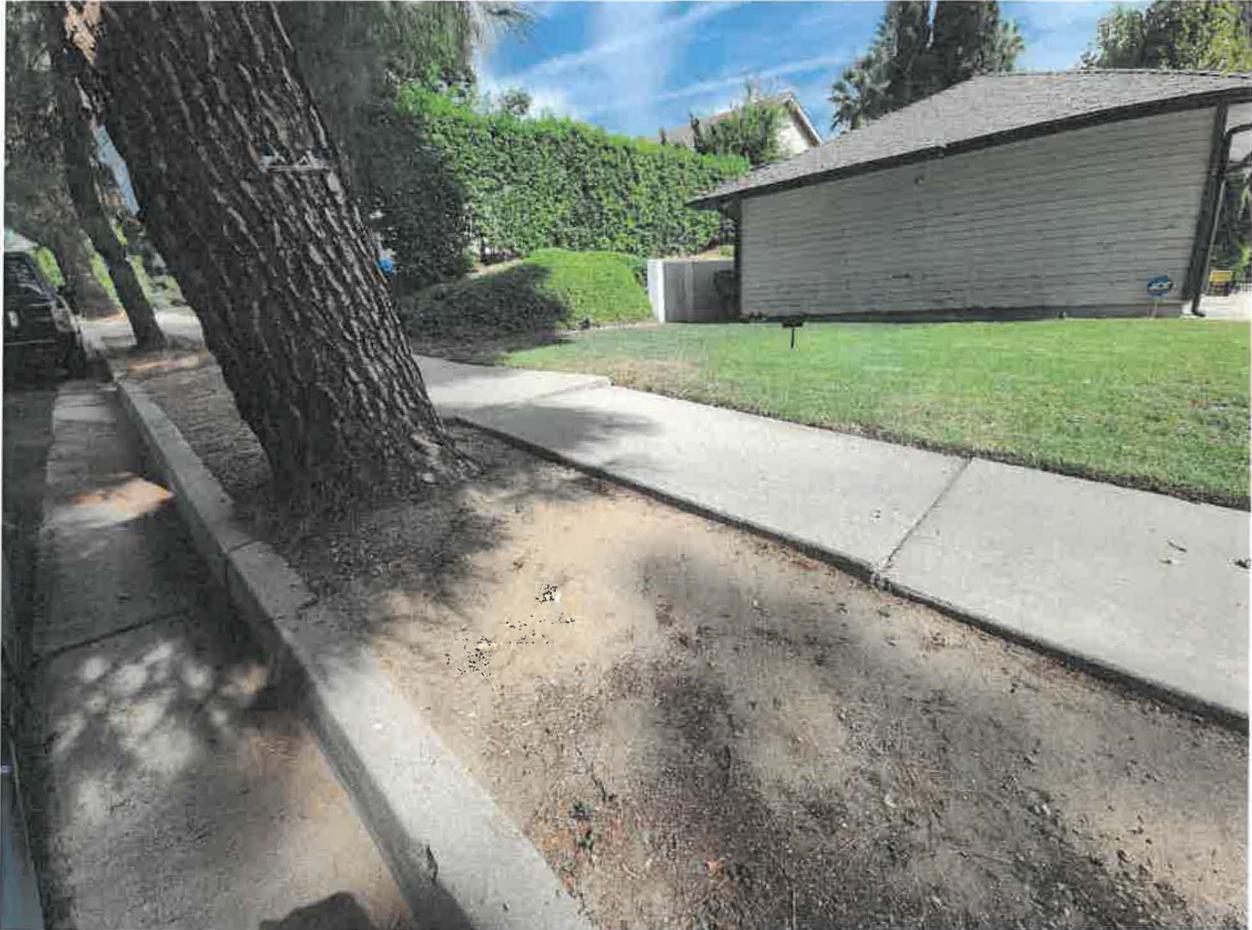
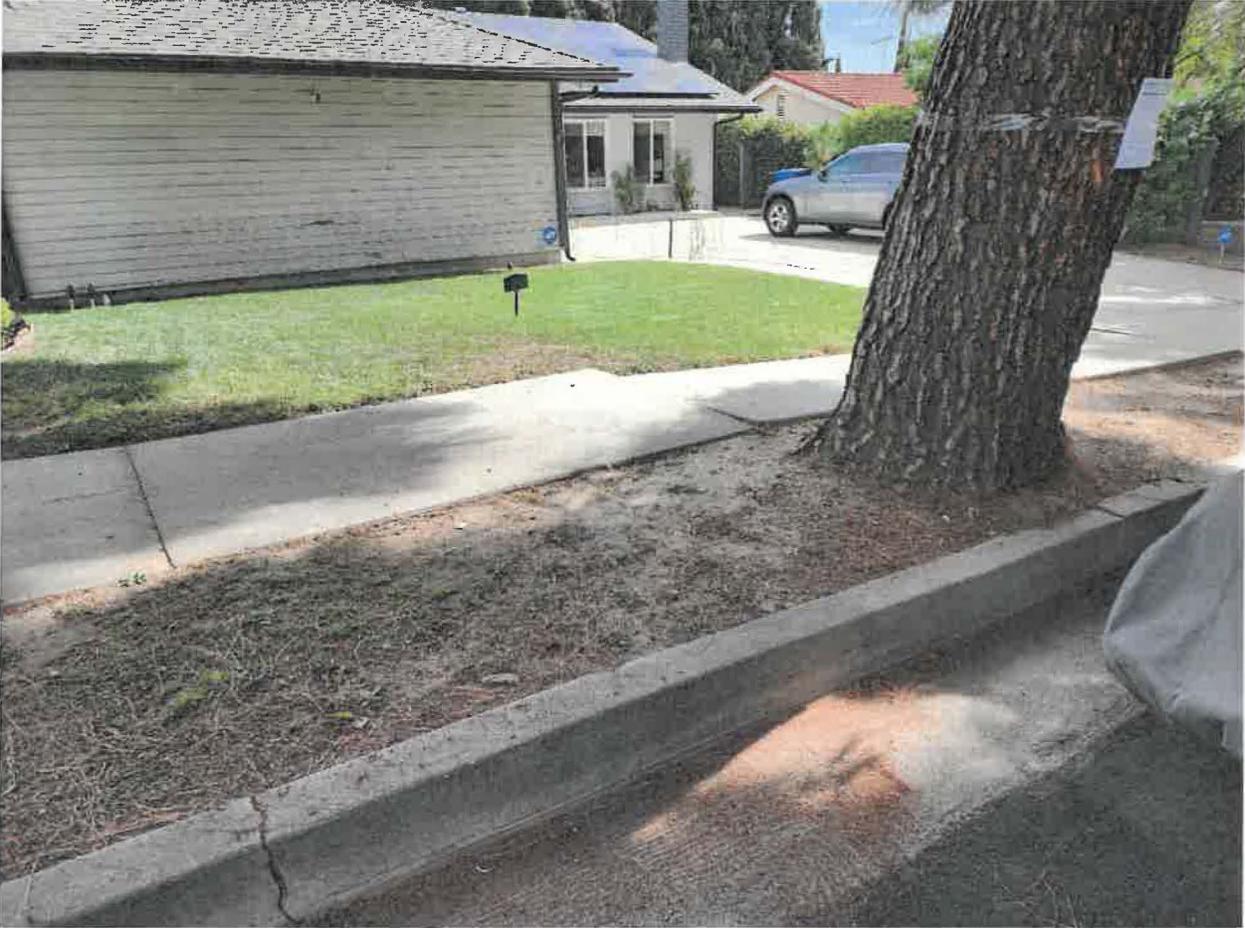
10132 YOLANDA AVE (F1)

Proposed to be Removed - UFD cannot ramp over the pine tree roots since the prevailing grade of the street exceeds 5%. The Canary Island pine has an elevated root flare creating severe off grade sidewalk conditions. Large diameter roots are extending under the existing sidewalk. Excessive/ imprudent amount of roots would require pruning to achieve ADA grade requirements & Certificate Of Compliance. Ramping over roots and sidewalk width reduction have been considered as an effort toward tree-preservation yet would not be sufficient due to the extent of repairs surrounding this parkway tree. Root pruning of critical roots will render the trees unstable. Removal is recommended as the best course of action. This genus of trees and its inherent intolerance to root-pruning is the primary factor in UFDs recommendation that no anchoring roots shall be severed at time of Demolition/construction.

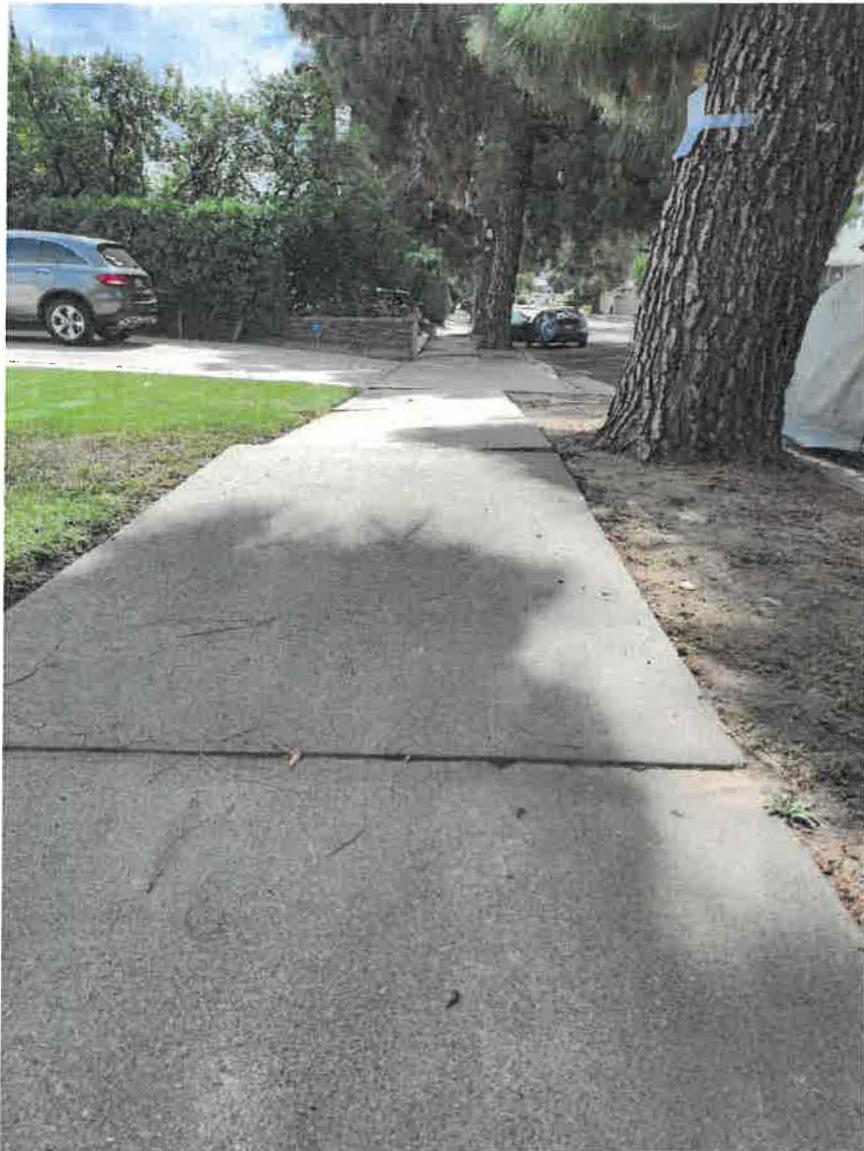
10132 YOLANDA AVE (F1)

Proposed to be Removed - UFD cannot ramp over the pine tree roots since the prevailing grade of the street exceeds 5%. The Canary Island pine has an elevated root flare creating severe off grade sidewalk conditions. Large diameter roots are extending under the existing sidewalk. Excessive/ imprudent amount of roots would require pruning to achieve ADA grade requirements & Certificate Of Compliance. Ramping over roots and sidewalk width reduction have been considered as an effort toward tree-preservation yet would not be sufficient due to the extent of repairs surrounding this parkway tree. Root pruning of critical roots will render the trees unstable. Removal is recommended as the best course of action. This genus of trees and its inherent intolerance to root-pruning is the primary factor in UFDs recommendation that no anchoring roots shall be severed at time of Demolition/construction.
